**Weaver Street over New England
Central Railroad
Structural Assessment**
Winooski, VT

November 18th, 2011

WEAVER STREET OVER NEW ENGLAND CENTRAL RAILROAD**STRUCTURAL ASSESSMENT**

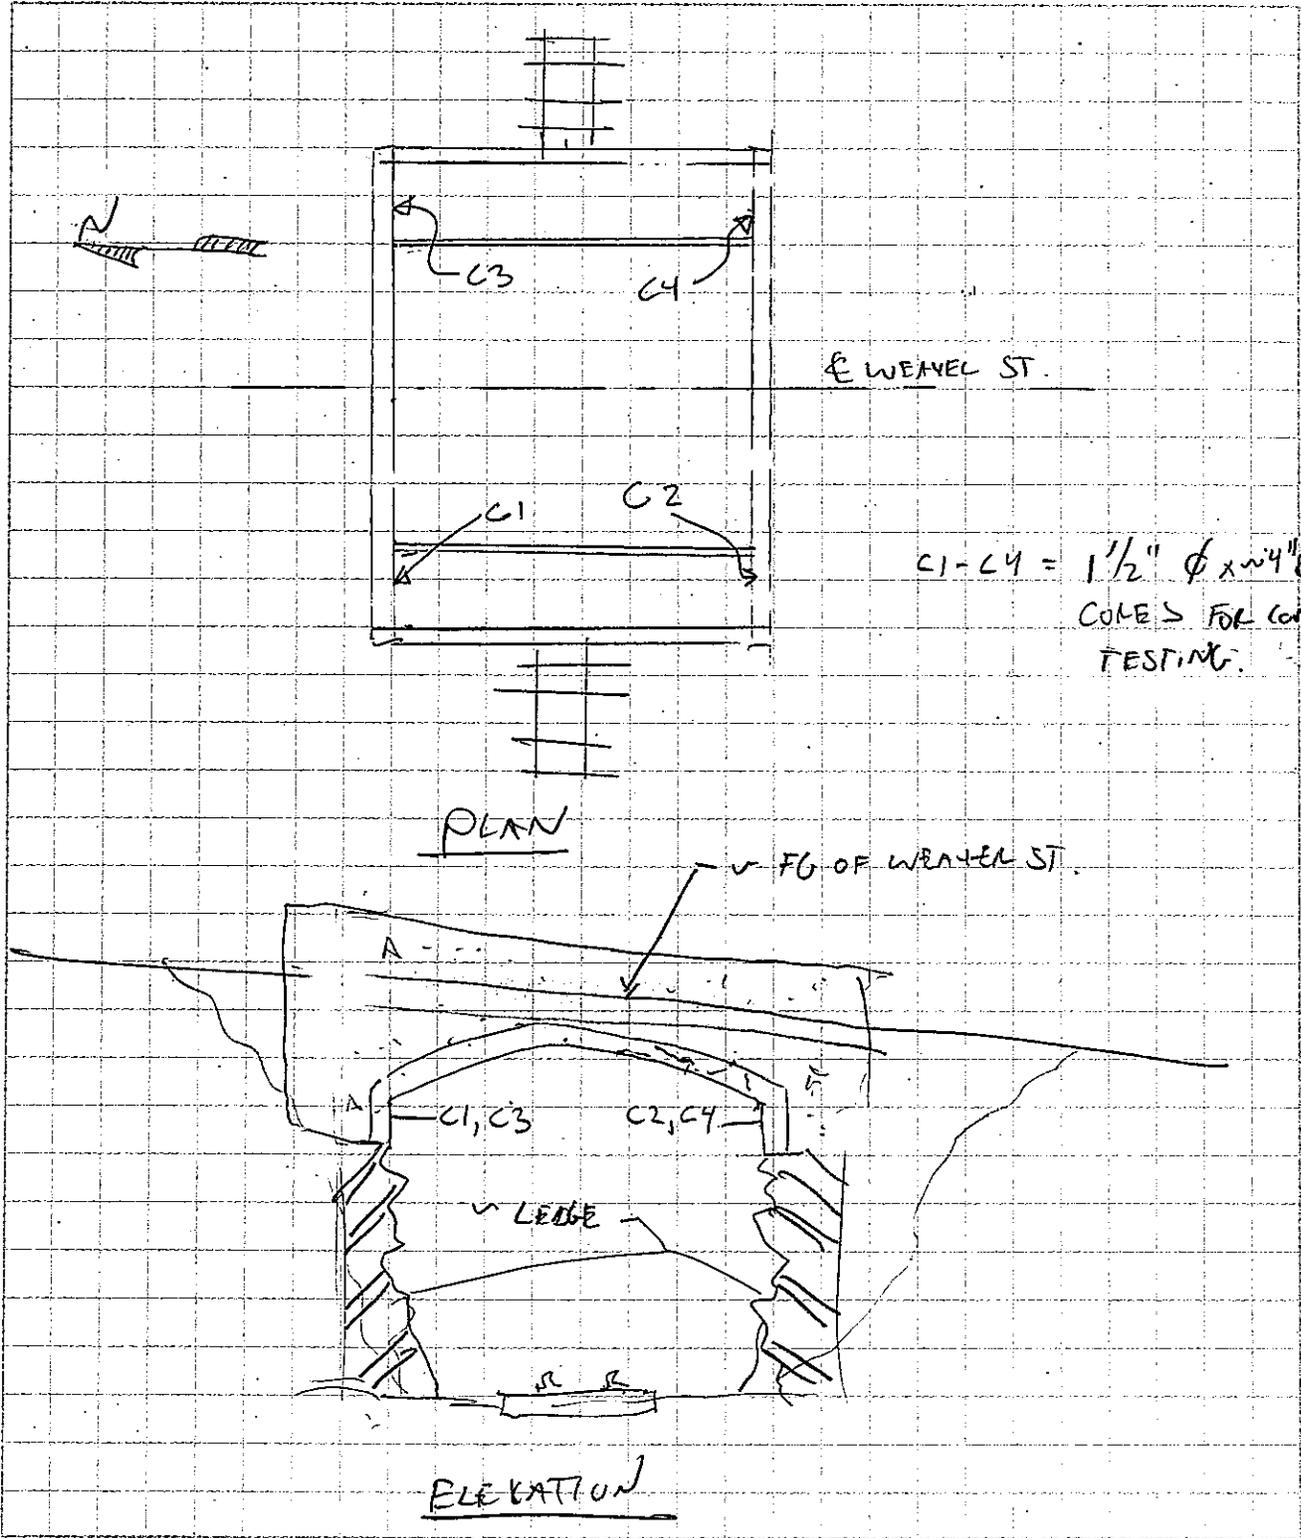
WEAVER ST. - CONCRETE TESTING LOCATIONS

ATL Sample No.	Depth of Carbonation* (in.)	Depth of Chloride Sample* (in.)	Chloride (%)
CT3158C1	1.6	2.0	0.110
		3.5	0.114
CT3158C2	1.6	2.0	0.117
		3.5	0.173
CT3158C3	Full Depth	2.0	0.064
		3.5	0.056
CT3158C4	1.9	2.0	0.050
		3.5	0.041

C1-C4 = 1 1/2" ϕ x 4" DEEP
CONES FOR CONCRETE
TESTING.

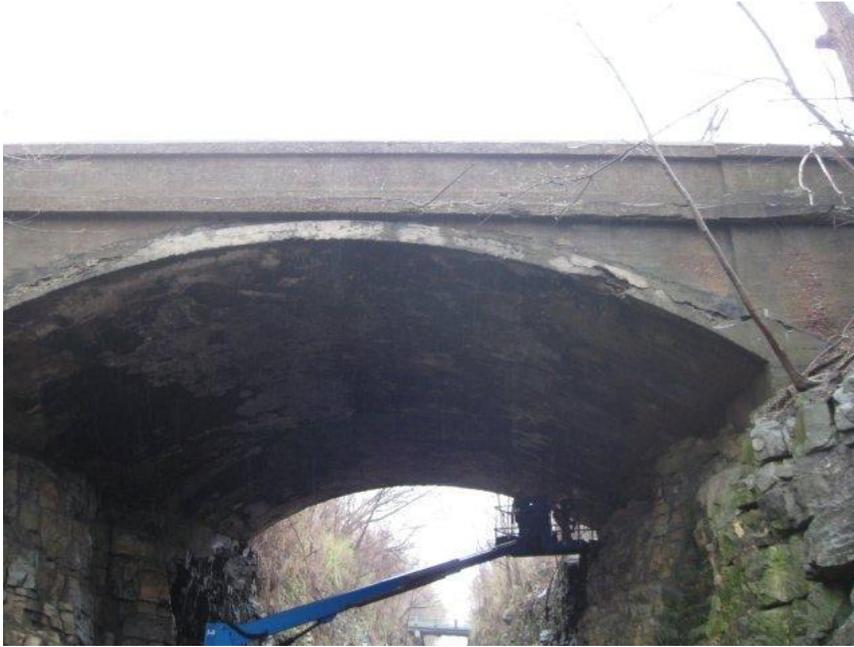
PHOTO 1: WEST FASCIA: CRACKING, SPALLING SOFFIT

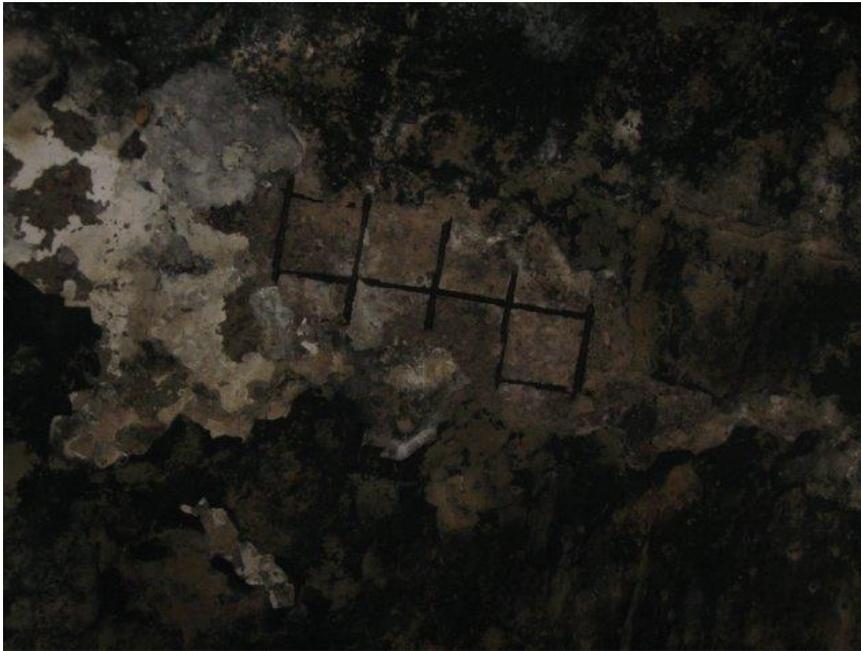
PHOTO 2: SPALLING SOFFIT, EXPOSED REBAR

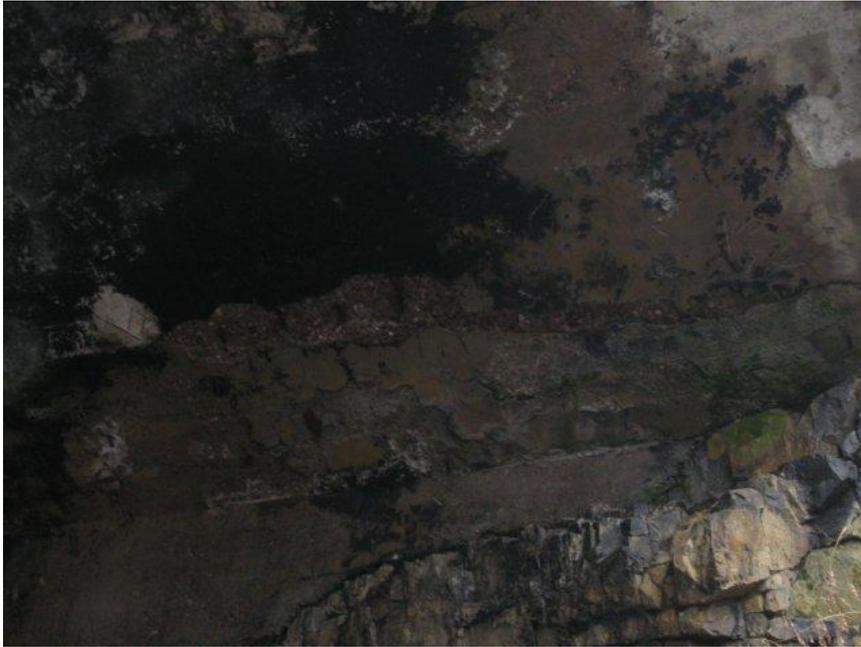
PHOTO 3: SPALLING SOFFIT, EXPOSED REBAR

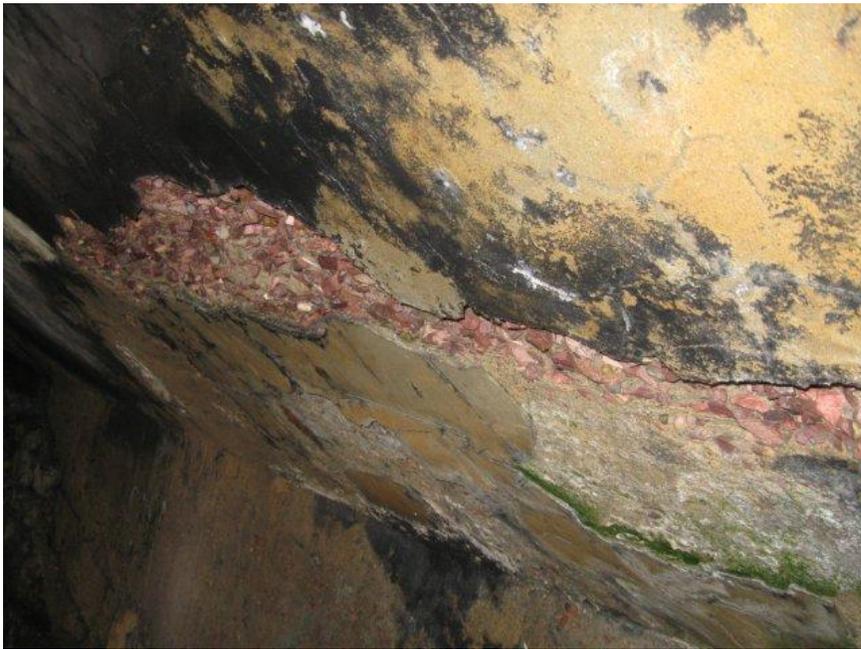
due to poor mixture of the aggregate and cement in the original construction. It was observed that the original concrete was poorly mixed and poorly consolidated, with many voids, and some areas having large concentrations of stone with little or no cement and other areas with a mixture of sand and cement with little or no aggregate.

PHOTO 4: CLOSE UP, POORLY MIXED CONCRETE

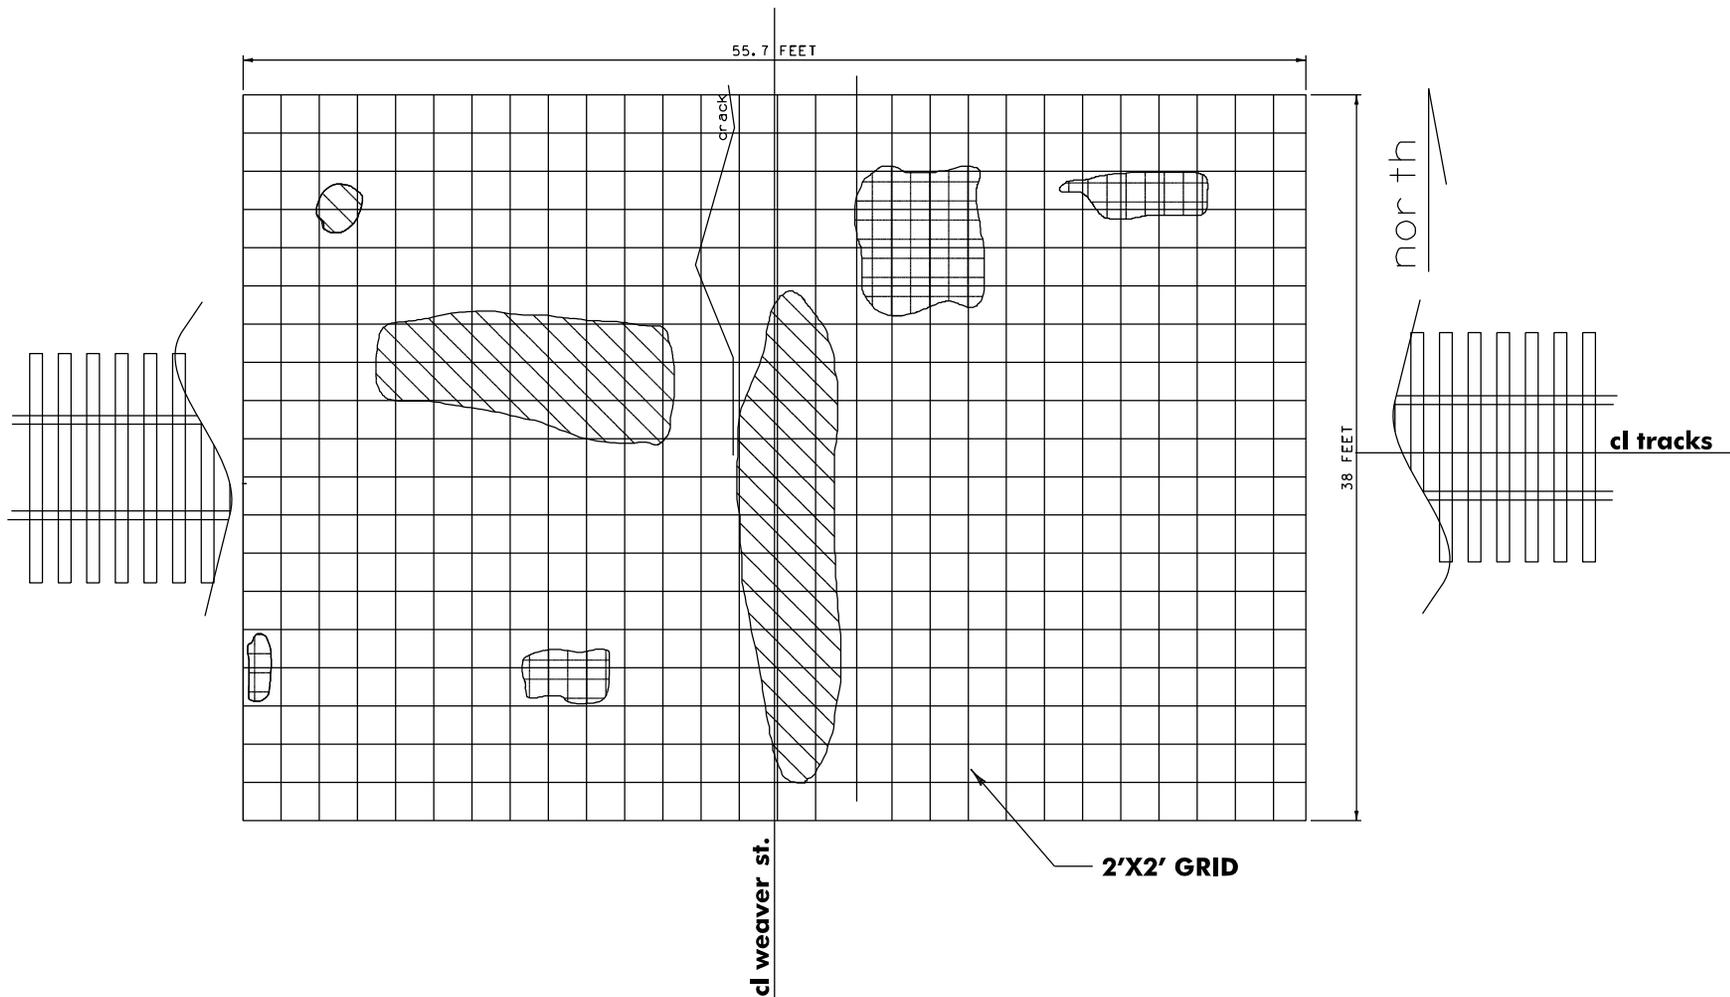
WEAVER ST. OVER NECR REFLECTIVE CEILING PLAN

**Sketch of Spalling Areas, Arch Soffit
By Stantec - April, 2011**

spalling

spall w/ rebar exposed

This reflective ceiling plan is a snapshot of the condition of the arch soffit at the time of inspection. The sketch is approximate (made without measurements). This sketch was made prior to sounding the underside of the soffit in April, 2011. The intent is to update this sketch at subsequent inspections to track the progress of deterioration.
