Road Safety Audit Review

Pond Road

Town of Hinesburg

Pond Road Road Safety Audit Review Review Report

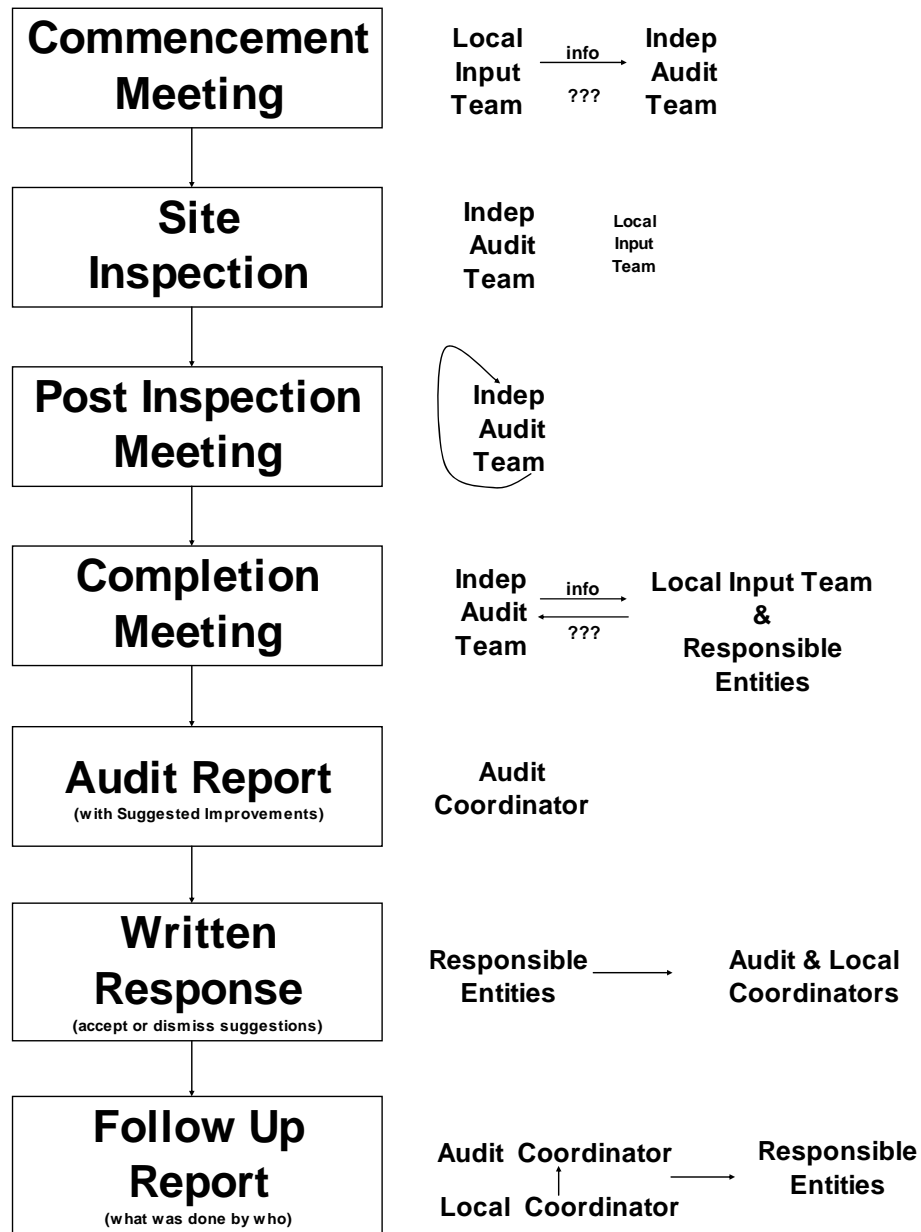
Figure 1. ROAD SAFETY AUDIT PROCESS

The RSAR process is composed of several steps as shown in the diagram below. The process starts with a **Commencement Meeting** between the Local Input Team and the Audit Team. The purpose of the meeting is for the Local Input Team to present community concerns to the Audit Team. A **Site Inspection** is then performed by the Audit Team. Members from the Local Input Team can accompany the Audit Team to further explain concerns. The site visit involves the identification of safety deficiencies as seen in the field. The Audit Team will usually drive through the location of interest to

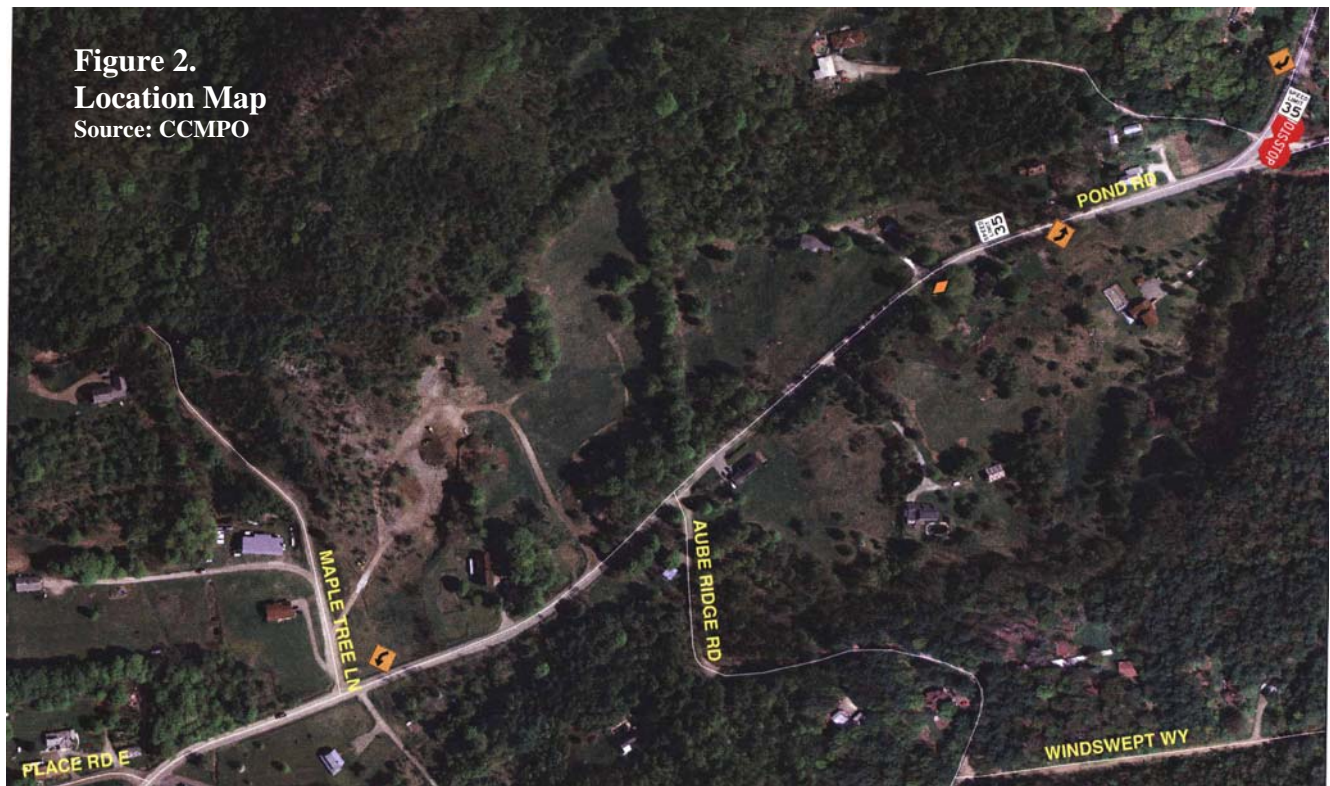
The location of this RSAR is the section of road on Pond Road between Place Road and Kozas Run.

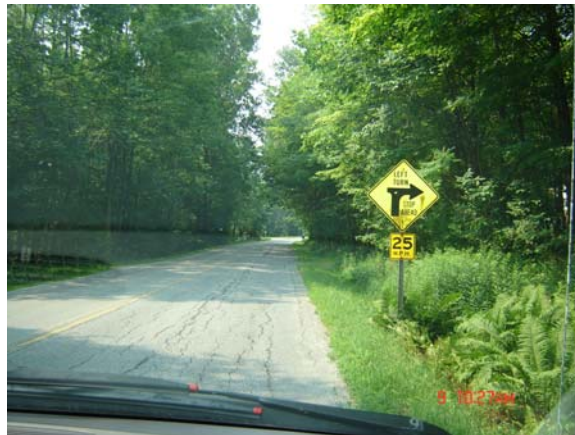
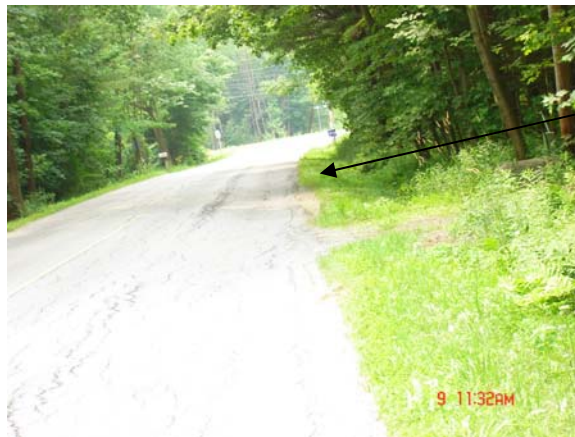
Curve at Pond Brook Road

Pond Brook Rd

SW, replace the custom made sign. Use the custom symbol without the wordings or use a modified turn sign with a side road (W1-1Md R)

Replace the advisory speed plaque with a new 21" x 21" plaque (W13-1)

Install a Pond Brook Rd sign (W16-8)

Add a new black on white, 30" x 36" Left Turn Yield to Thru Traffic (VR-615)

Clearly mark the 40' centerline break

Add a 48" x 24" arrow (W1-6) on two posts in the island and another one after Pond Brook Rd

Could also use W1-1Md R with a new 21"x21 W13-1 and a W16-8

Add a new VR-615 between the mailbox and the drive

Add two new W1-6

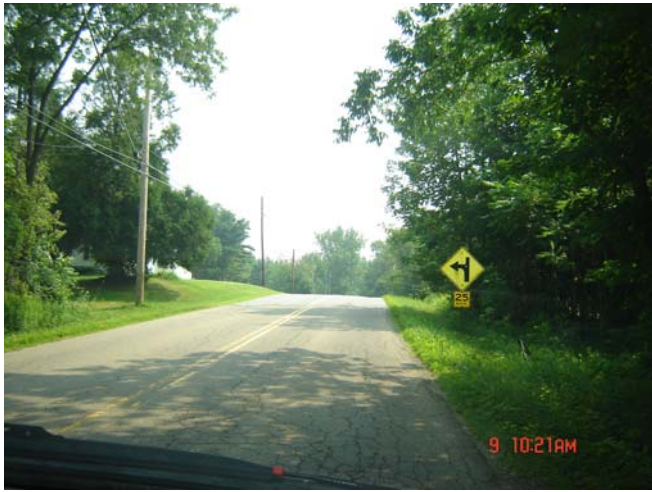
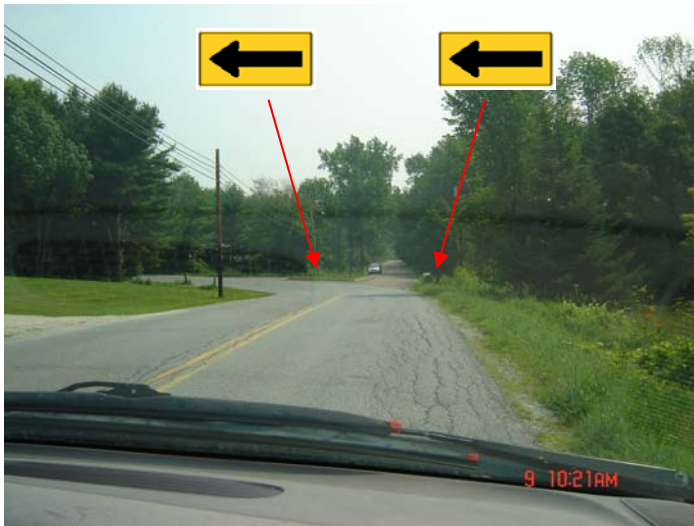
Pond Brook Rd

NE, replace the custom made sign with new sign or use a 30" x 30, AOT modified curve sign (W1-1Mb L)

Replace the advisory speed plaque with a new 21" x 21" plaque (W13-1)

Add a 48" x 24" arrow (W1-6) on two posts before Pond Brook Rd and another one in the island

Could also use
W1-1Mb L with a
new 21"x21 W13-
1 and a new W16-
8

Add two
new W1-6

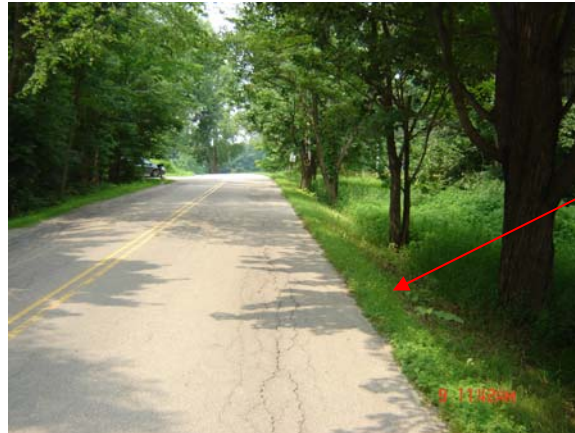
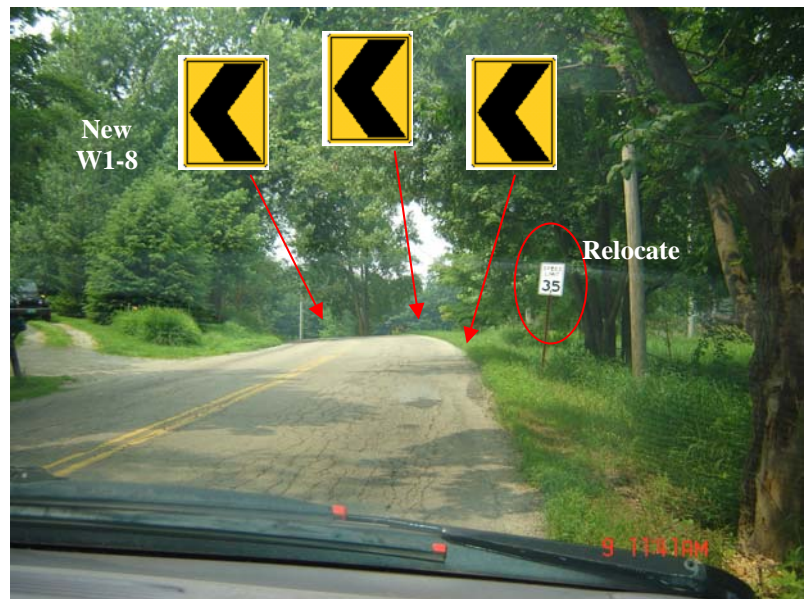
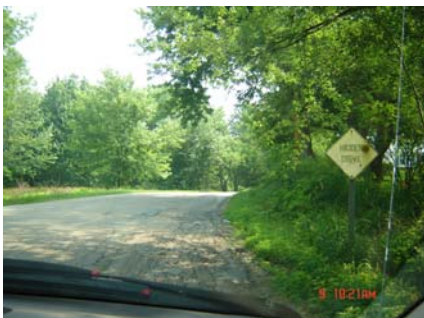
Curve near 975 Pond Road

SW, add a new 30" x 30" curve sign (W1-2 L)

Relocate (replace with new 24" x 30", type III R2-1) the speed limit sign to 120 ft west of mail box 1081

Add 24" x 30" chevrons (W1-8) 120 ft apart

NE, Replace the Hidden Drive with a new 30" x 30" Hidden Drive Right (VW-054)

New W1-2L

New W1-8

Relocate

Replace with new VW-054

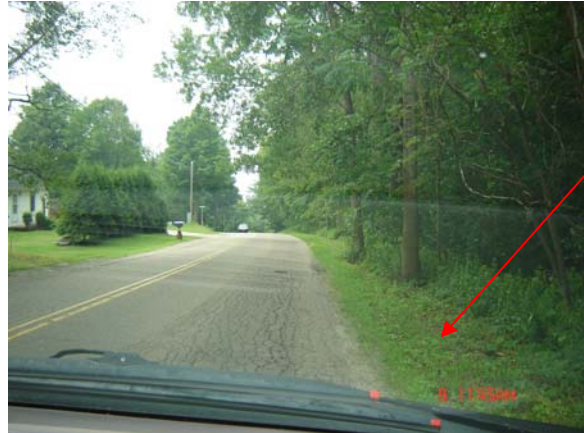
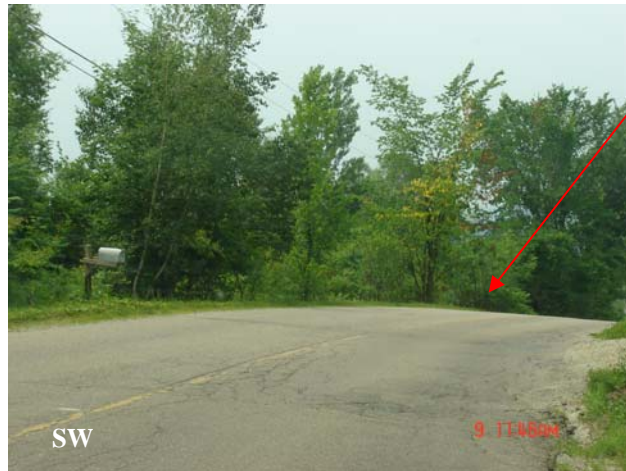
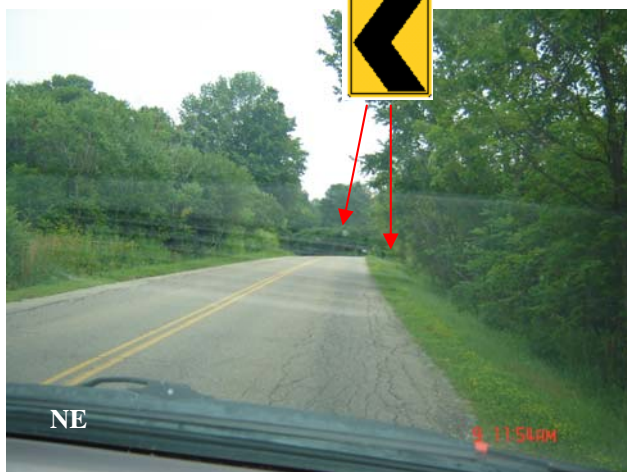
S curves near Aube Ridge Rd

SW, add a new 30" x 30" reverse curve sign (W1-4 L)

Add two 24" x 30" chevrons (W1-8) near 751 Pond Road 120 ft apart

Add a 30" x 30" curve sign (W1-2 L)

New W1-4L

Add two chevrons (W1-8)

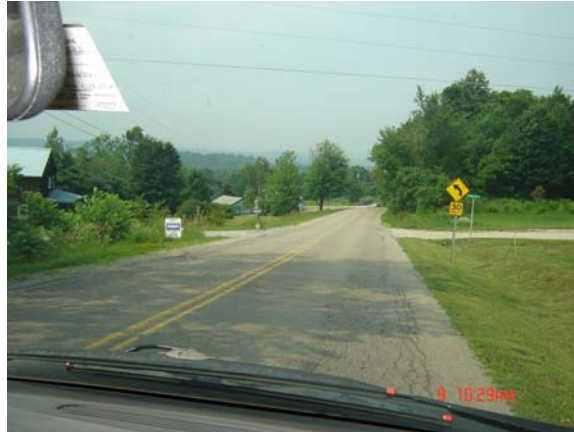
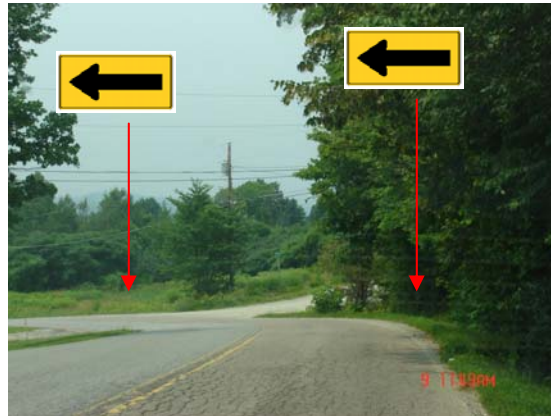
Curve near Place Road

SW, replace the curve sign with a new 30" x 30" curve/side road sign (W1-10 L)

Replace the advisory plaque with a new 21" x 21" advisory speed plaque (W13-1)

Add a 48" x 24" arrow (W1-6) on two posts before and after Place Road

Replace with New W1-10 L

New 21" x 21" W13-1

Add two new W1-6

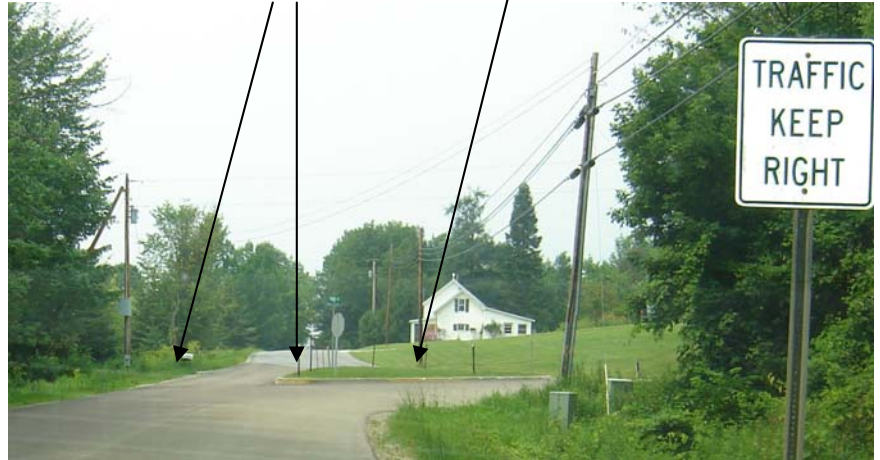
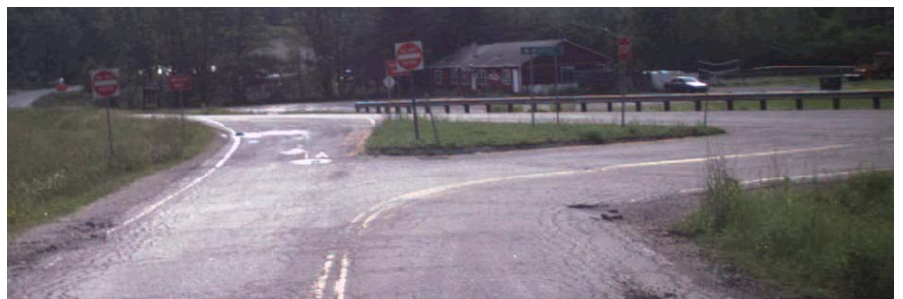
The conspicuity of the island on Pond Brook Road could be improved

Example of centerline markings that follow the curvature of the road

Facing Pond Brook Road, install a Do Not Enter sign (R5-1) on the left hand side of the island & on the left hand side of the road

Facing Pond Brook Road, install a 48" x 24" arrow (W1-6) pointing to the right. The arrow should be placed in the apex of the curve

Paint the curb (all sides of the island) with reflective yellow paint

Delineate the island with a yellow edgeline on the one way slip ramp and with white edgelines the other two sides

Continue the double line centerline marking so that it follows the curve

Add a stop bar at the end of the island for SW motorists going onto Pond Brook Road

New R5-1

New W1-6

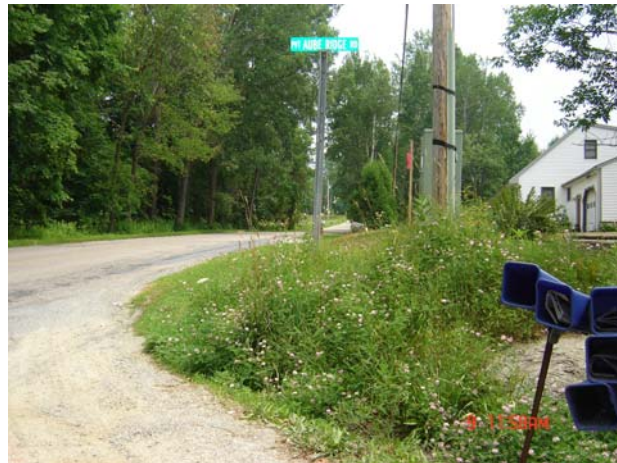
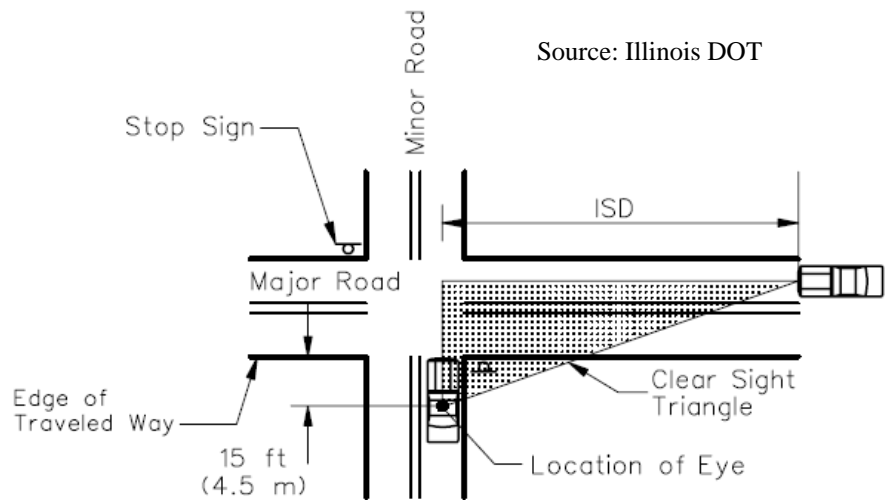
Corner sight distance to the right on Aube Ridge is slightly obstructed

Remove obstruction outside of the corner

Promote a clear sight triangle as recommended by AASHTO

From the edge of the road, measure 15 ft back (this is the vertex of the sight triangle)

For an estimated traveling speed of 40 mph, "ISD" is 390 ft

Anything within the triangle area such defined should be as much as possible removed

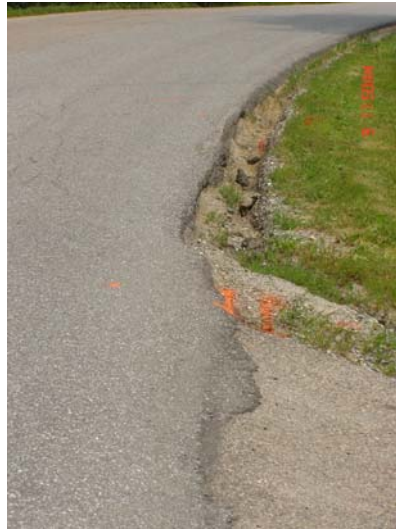
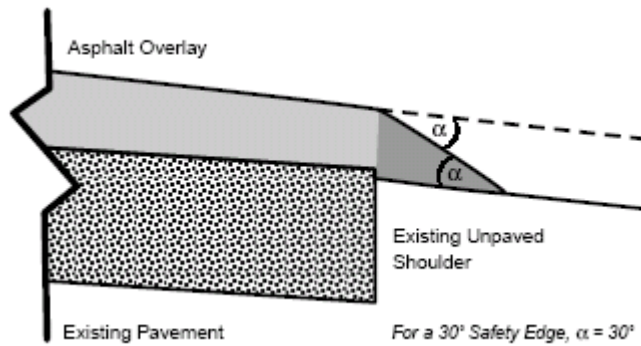
Severe edge drop-offs could cause motorists to lose control

The edge drop that is being created could cause a motorist that went of the road to lose control when trying to get back on the pavement

Drop-offs of three or more inches are unsafe if the roadway edge is at a 90-degree angle to the shoulder surface

Review the locations where edge drop-offs exist

Consider specifying a 30-35 degree angle asphalt fillet (called the "Safety Edge" by FHWA) in the contract specification of the next paving project for this road

Pull up the shoulder area where applicable

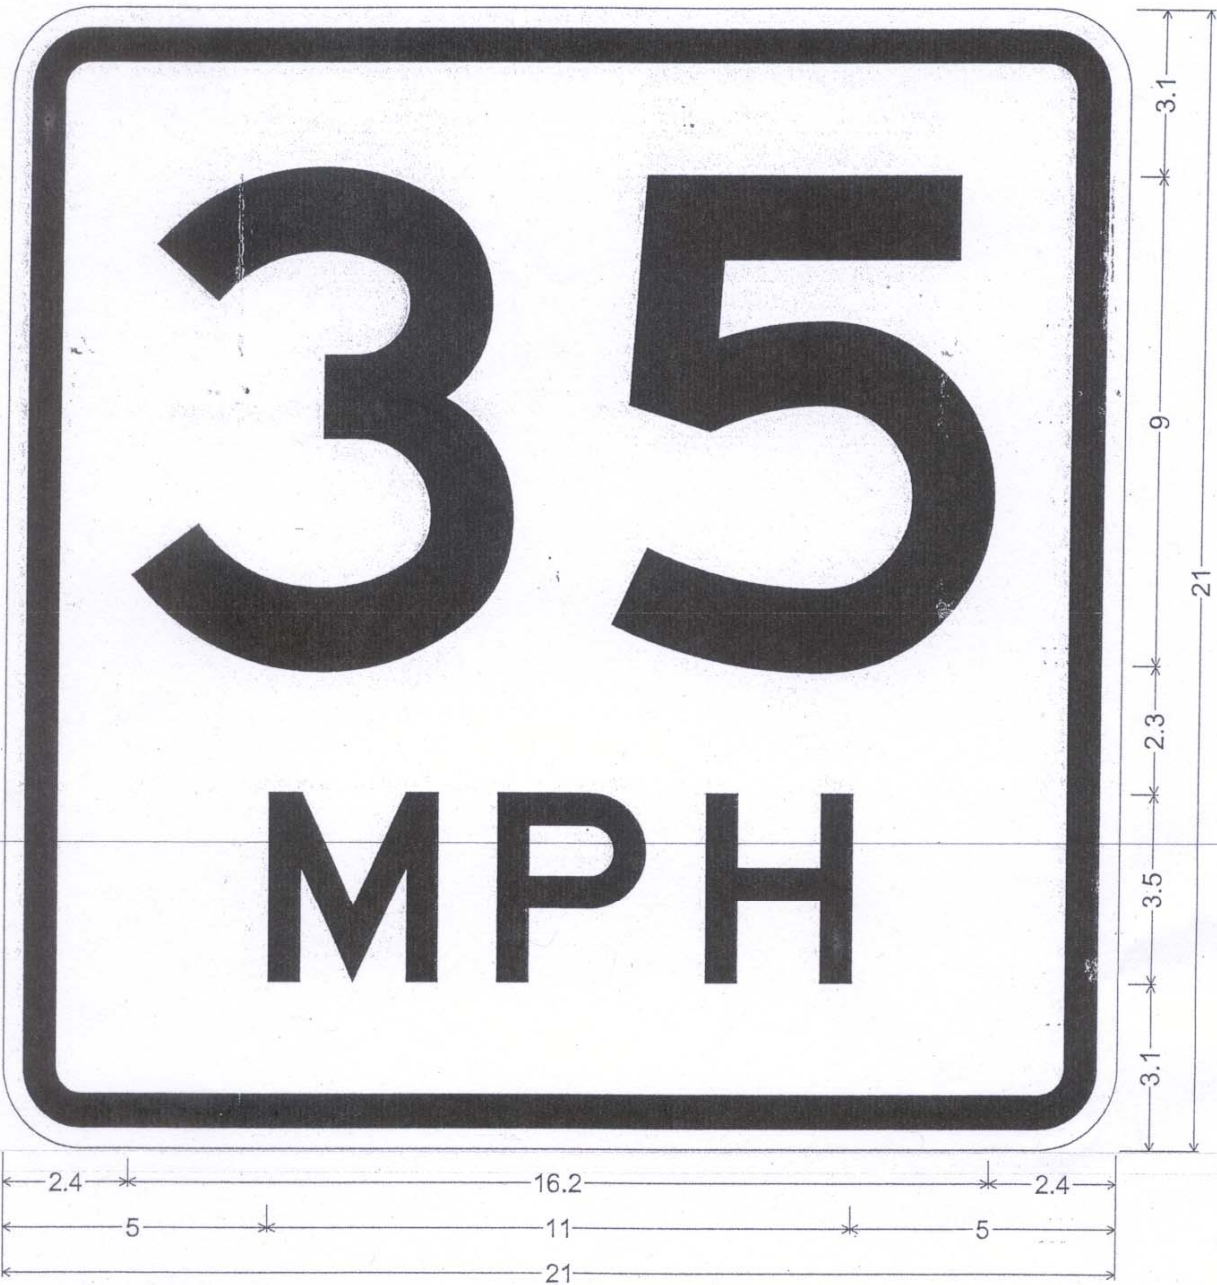
21" x 21" W13-1 Advisory Speed Sign

W13-1 STD; 1.5" Radius, 0.6" Border, 0.4" Indent, Black on Yellow;
"35" E 80% spacing; "MPH" E 122% spacing;

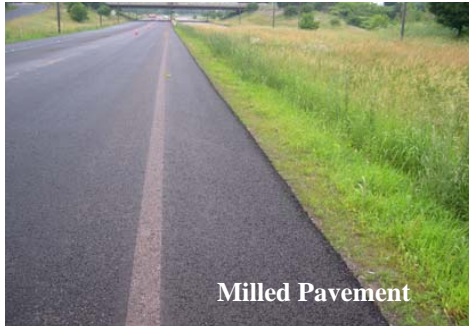
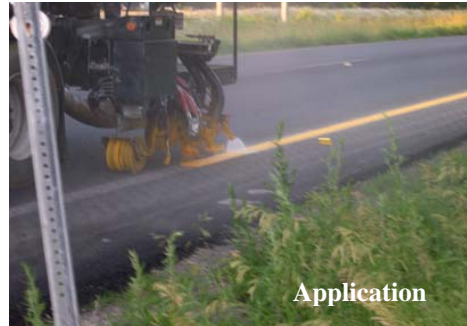
Recessed Pavement Markings

Involved milling the pavement with specialized equipment and applying application of marking materials. Markings are more visible and last longer.
