Road Safety Audit Review

Browns Trace Road

Town of Jericho

July 10, 2008

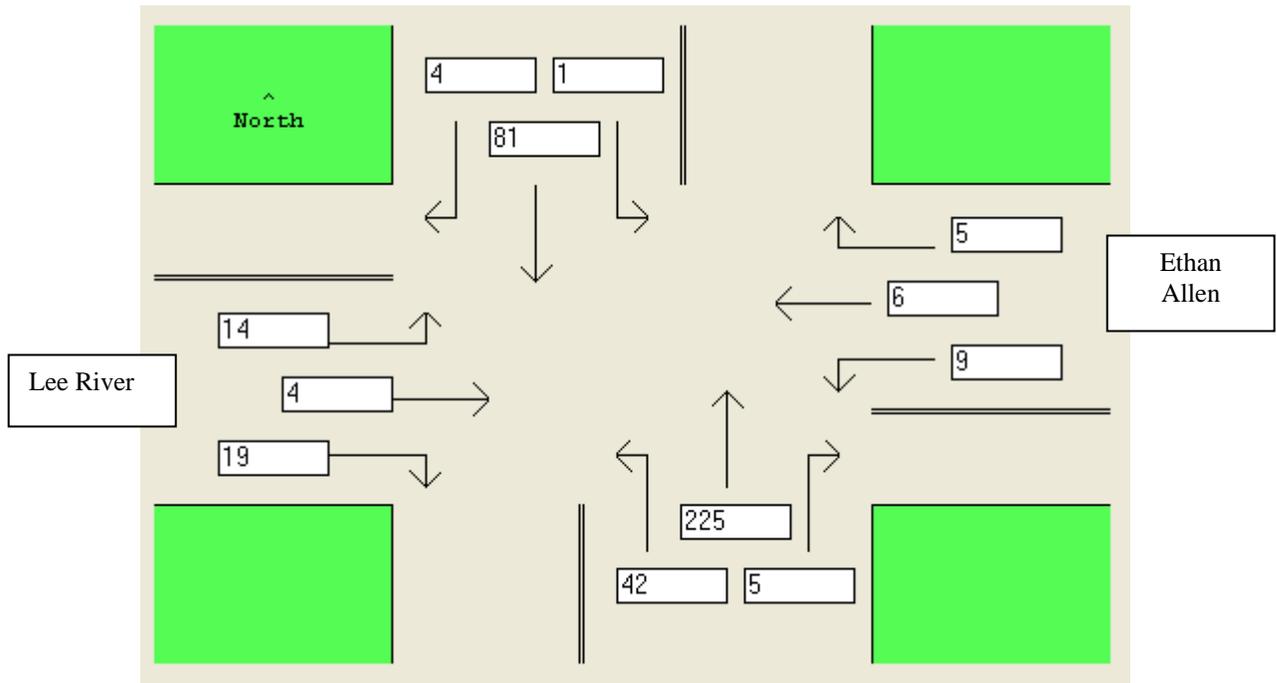
Figure 3. PM Peak Hour Volumes

A turning movement count was performed during the morning and afternoon peak hours by CCMPO in July 2008 (Figure 3). It was found that the largest volume of traffic in the morning was between 7:00 and 8:00 am with 396 vehicles and that in the afternoon, the hours of 5:00 pm to 6:00 pm had the largest amount of traffic with 420 vehicles.

Going southbound on Browns Trace Road, the predominant movement is the through movement and it is heavier in the morning (277 vehicles vs 81). In the afternoon, in the northbound direction, the through movement is also the predominant movement with heavier traffic in the afternoon (225 vehicles vs 53).

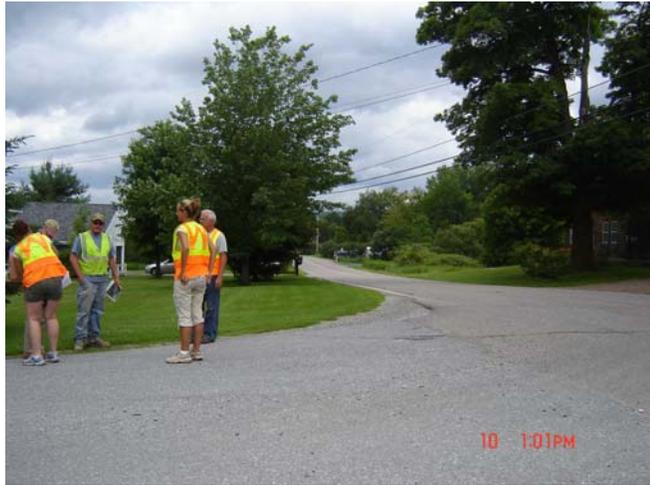
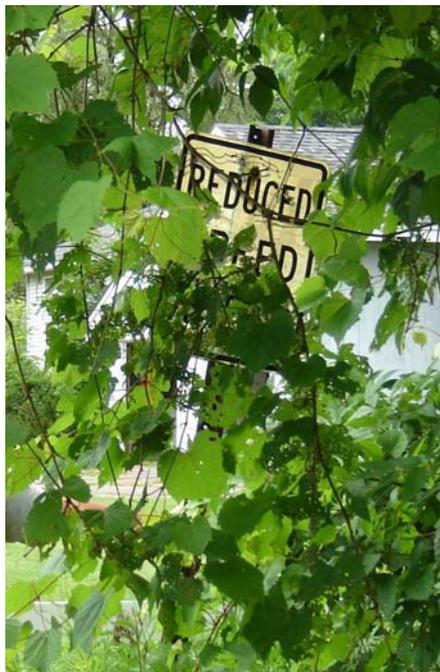
Problem:

Limited corner sight distance to the left when stopped at the Plains Road approach

Immediate:

Southbound, install a 30" x 30" side road sign (W2-2) with a Plains Rd name plaque underneath (W16-8)

Review the location of the beginning of the 25 mph speed zone in the southbound direction. Ideally, this zone should start at the same location as the 35 mph zone in the northbound direction

Replace the reduce speed ahead sign with a new 36" x 36" W3-5. Cut brush/relocate depending on previous action

Short Term:

Promote a clear sight triangle as recommended by AASHTO

From the edge of the road, measure 15 ft back (this is the vertex of the sight triangle)

For an estimated traveling speed of 25 mph, "ISD" is 280 ft

For an estimated traveling speed of 40 mph, "ISD" is 445 ft

Anything within the triangle area such defined should be as much as possible trimmed/removed/ relocated

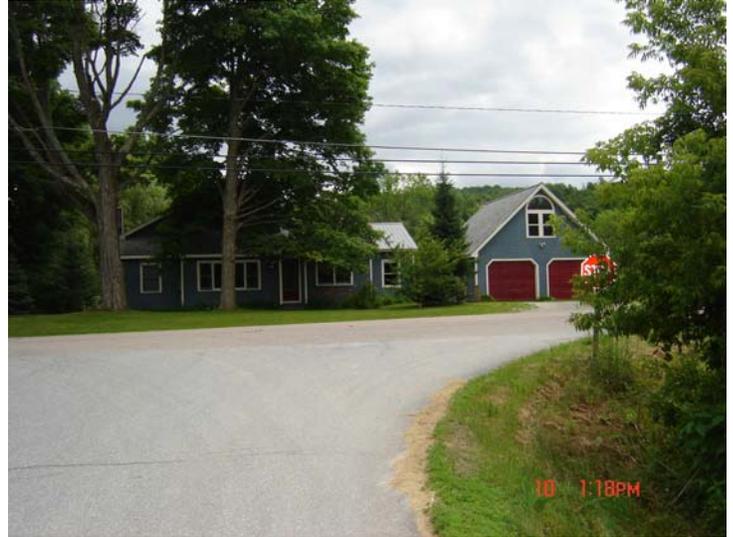
Problem:

The conspicuity of the approach to the intersection on Plains Road could be improved

Immediate:

Cut brush in front of the stop sign

Refresh the stop bar but reinstall 4 feet back from the edge of the road

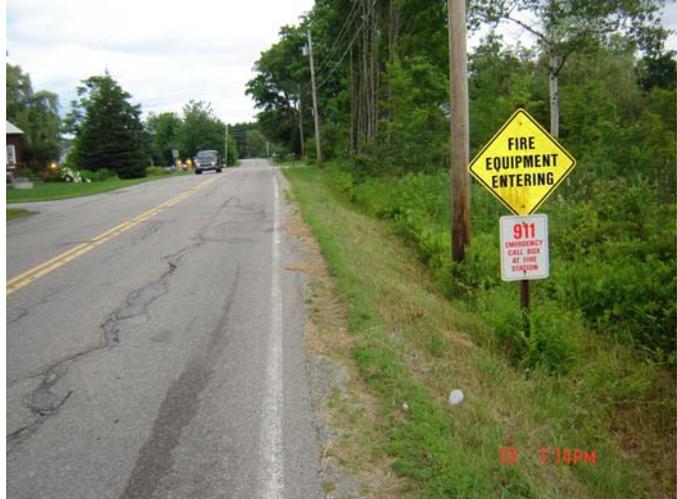
Problem:

Information pertaining to emergency vehicles is too far from the area of concern in the northbound direction

Immediate:

Relocate the sign within 1000 ft of the area of concern

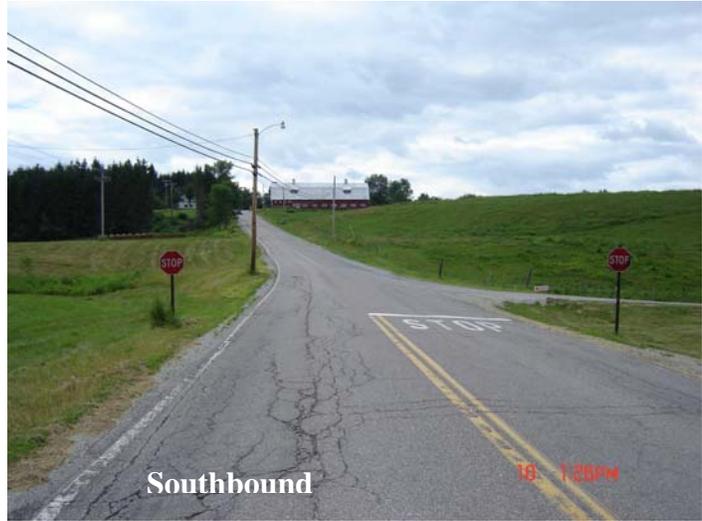
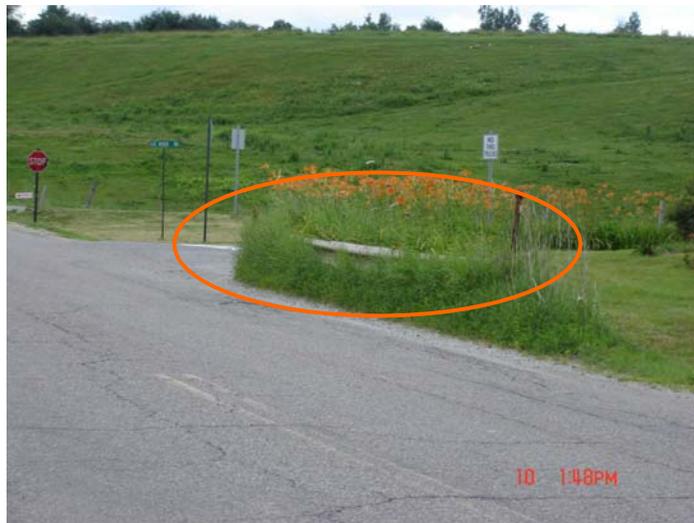
Problem:

The operation of the Lee River Rd intersection is unusual

Comment:

It is very unusual to have a major movement that is significantly heavier than the opposing traffic to be controlled by a stop sign

clear sight triangle

Immediate:

Replace the two stop signs (R1-1) with new 30" x 30" type III signs. Install the bottom of the sign not less than 5 ft above the surface of the road

On Lee River (west), replace the left turn Yield to oncoming traffic sign with a new 30" x 36" type III sign

Short Term:

If the alignment is kept as it is currently, then stripe the centerline markings so that the south to west movement is shown as the primary movement. Add a curve sign right (W1-2R) up the hill for the southbound direction and a modified curve right sign with a side road (AOT W1-mg R) for traffic approaching Lee River from the west

Alternatively, instead of a W1-2R, could simply add an intersection sign (W2-2) with a road name plaque (W16-8)

Promote a clear sight triangle as recommended by AASHTO

Consider redesigning this intersection into a regular 90-degree three-way intersection

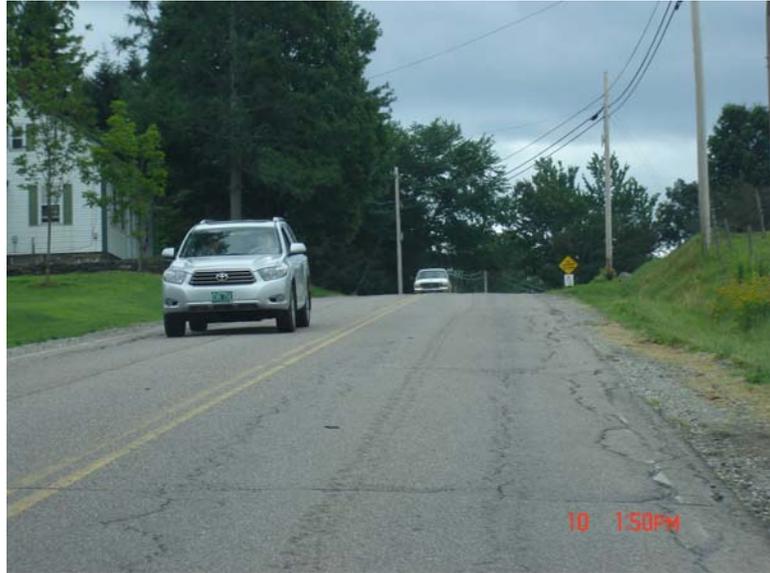
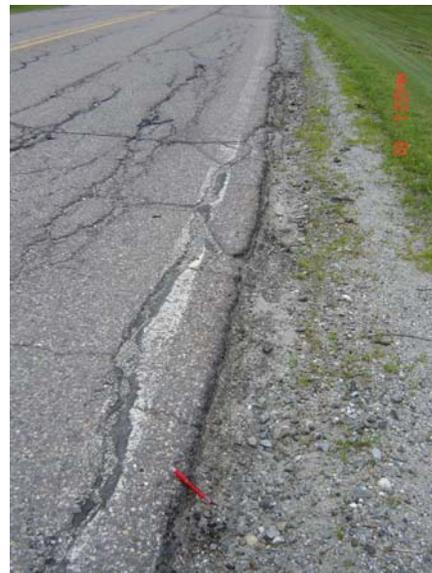
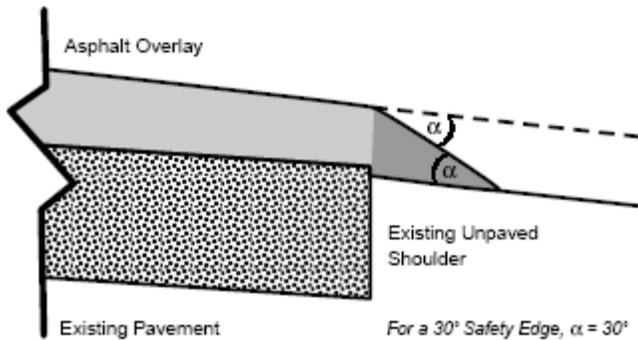
Problem:

Potential of edge drop-offs that could eventually cause motorists to lose control

The edge drop that is being created could cause a motorist that went of the road to lose control when trying to get back on the pavement

Drop-offs of three or more inches are unsafe if the roadway edge is at a 90-degree angle to the shoulder surface

Immediate to Short Term:

Review the locations where edge drop-offs exist

Pull up the shoulder area where applicable

Long Term:

Consider specifying a 30-35 degree angle asphalt fillet (called the "Safety Edge" by FHWA) in the contract specification of the next paving project for this road

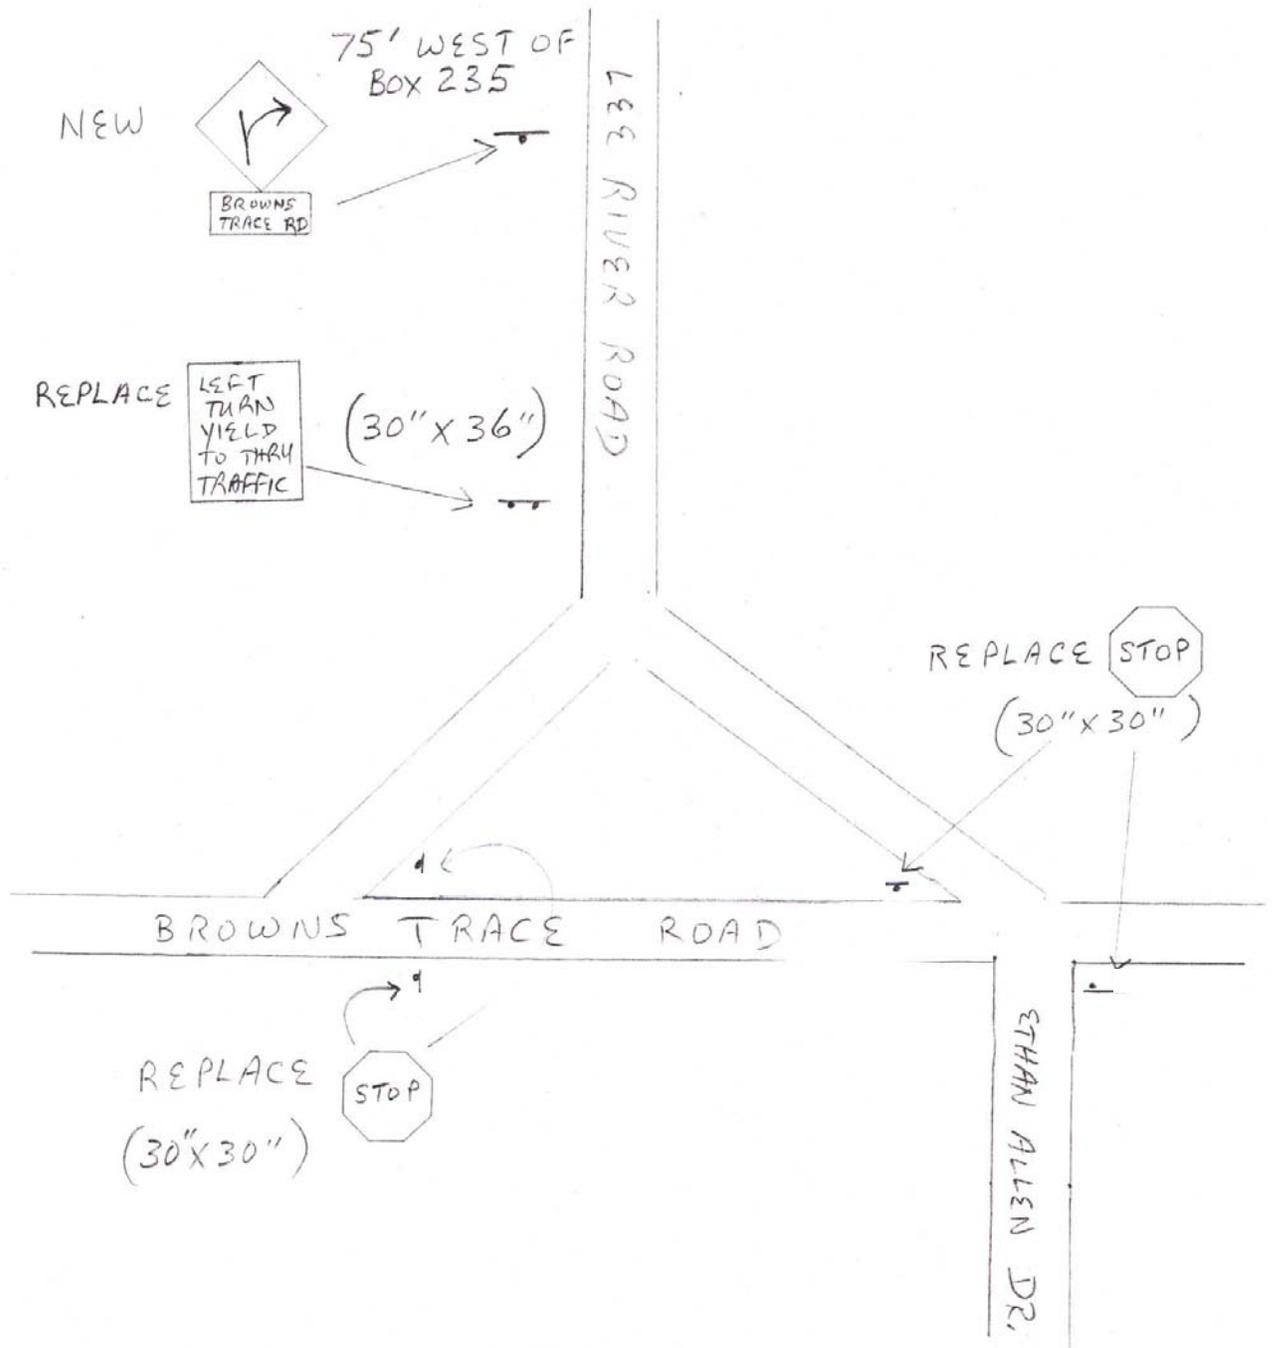
Appendix A –Proposed Signage

NEW

PUT IN PLACE OF CURRENT "FIRE EQUIPMENT ENTERING"

REPLACE

AND MOVE 25' NORTH OF POLE 349 A 89

±150' SOUTH OF SIGN: ETHAN ALLEN TRAINING SITE

AND MOVE OPPOSITE 35 MPH SIGN

(30" x 30") 83' SOUTH OF POLE 349 A 89

AND MOVE ACROSS FROM POLE 30C

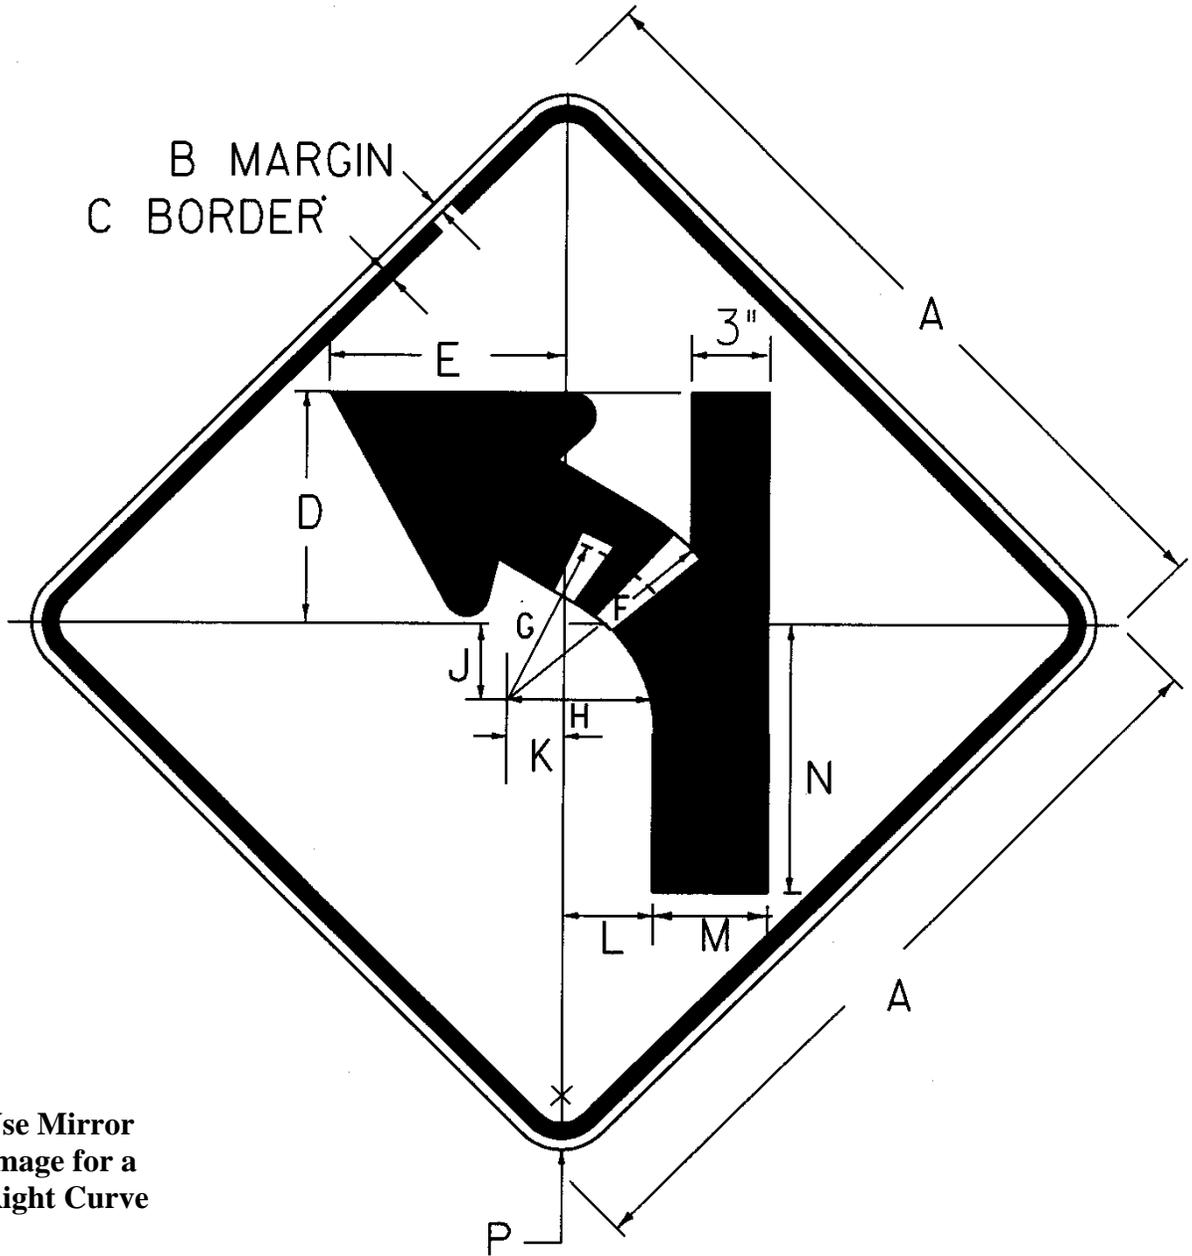
AOT W1-mg, Curve Sign

Use Mirror
Image for a
Right Curve

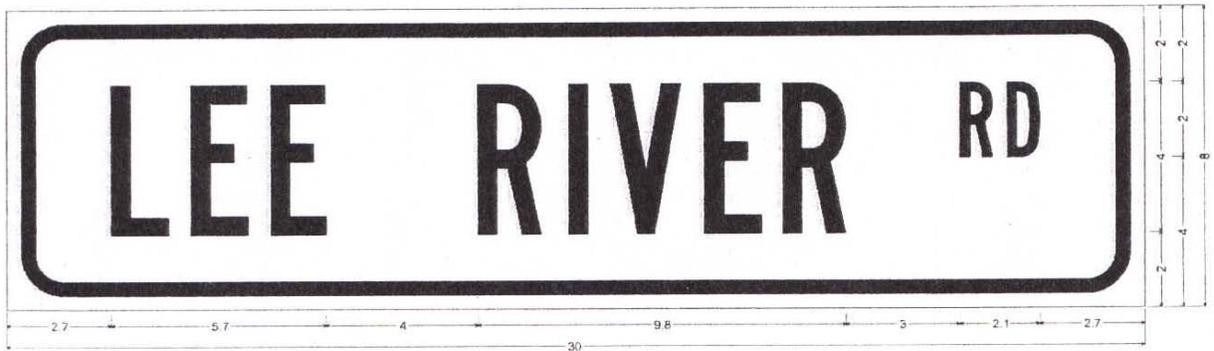
W16-8, Lee River Rd Supplemental Road Name Plaque

1.5" Radius, 0.4" Border, 0.4" Indent, Black on Yellow
"LEE RIVER RD" B.

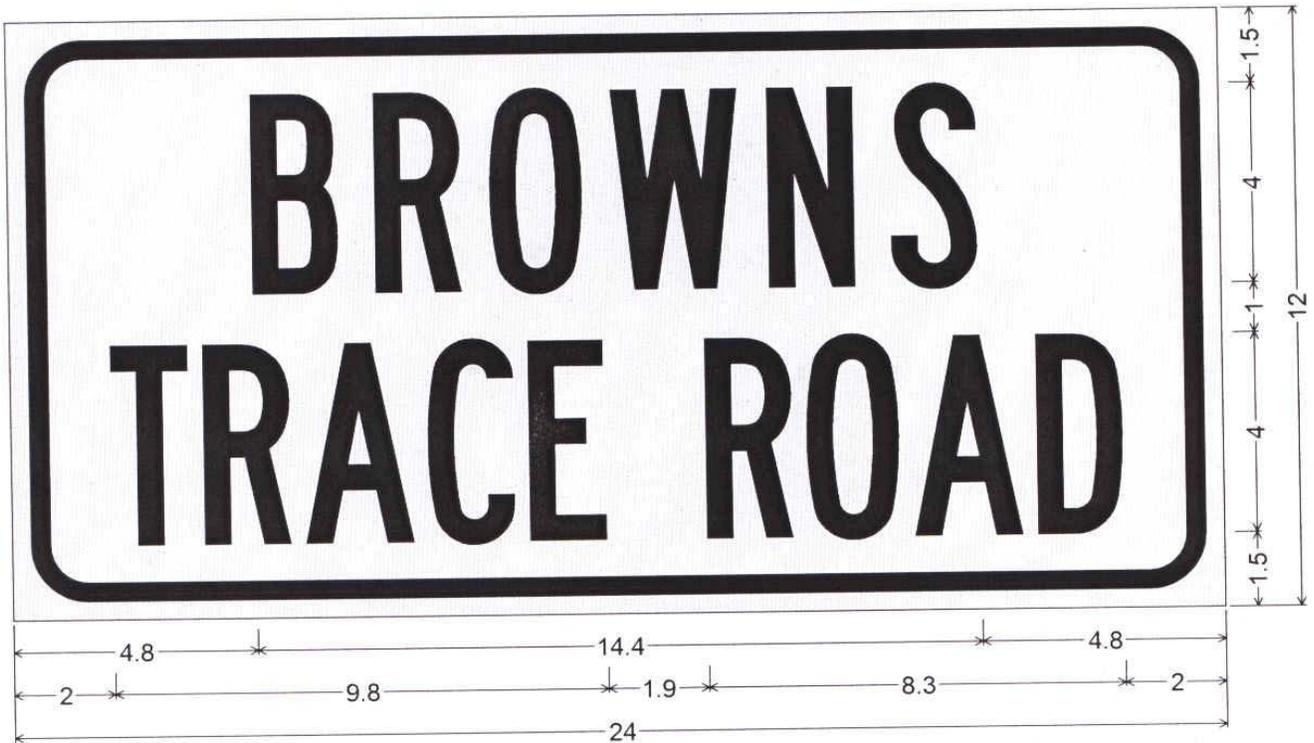
W16-8, Browns Trace Rd Supplemental Road Name Plaque

1.5" Radius, 0.4" Border, 0.4" Indent, Black on Yellow;
"BROWNS" B; "TRACE ROAD" B specified length;

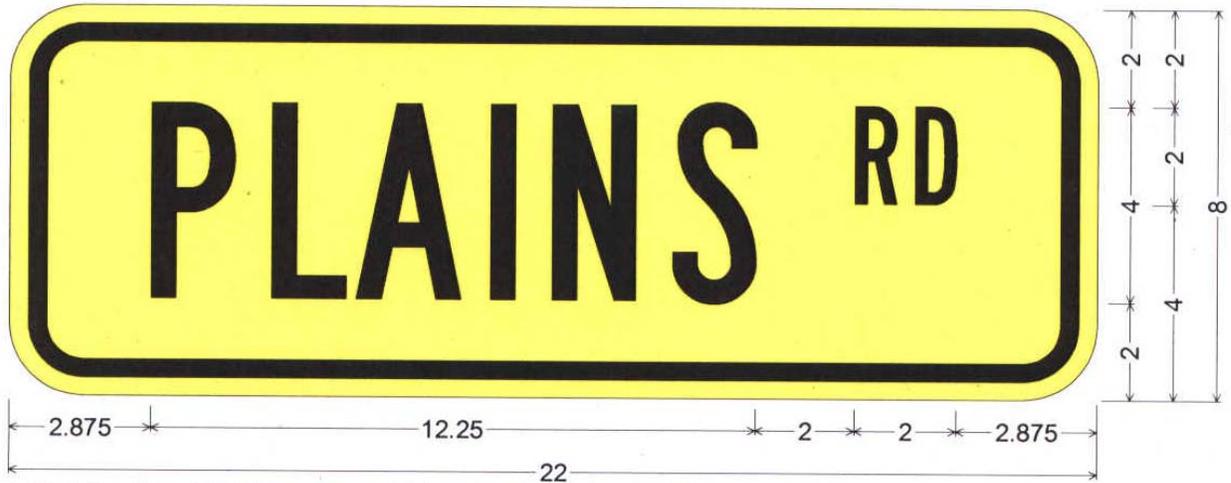
W16-8, Plains Rd Supplemental Road Name Plaque

1.500" Radius, 0.375" Border, 0.375" Indent, Black on Yellow;
"PLAINS RD" B;

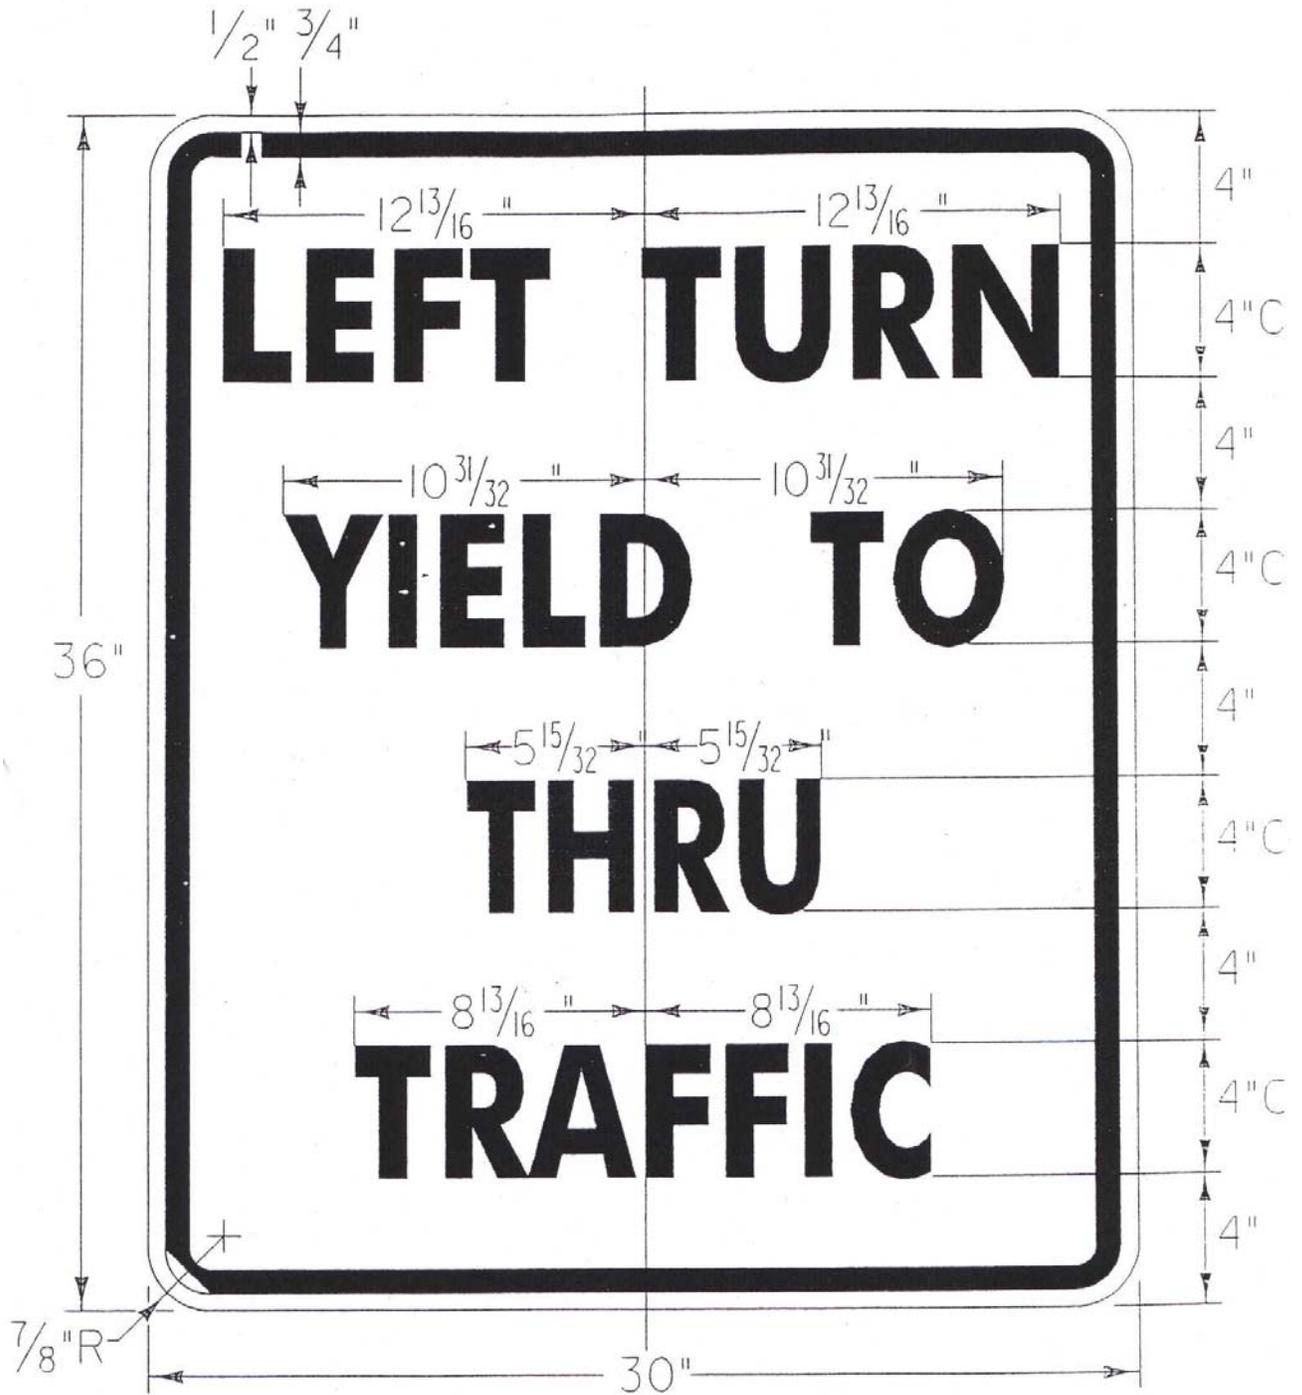
VR-615, Left Turn Yield To Thru Traffic

COLORS:

BLACK TEXT & BORDER
WITH WHITE BACKGROUND
