Metcalfe Drive Speed Study

Introduction

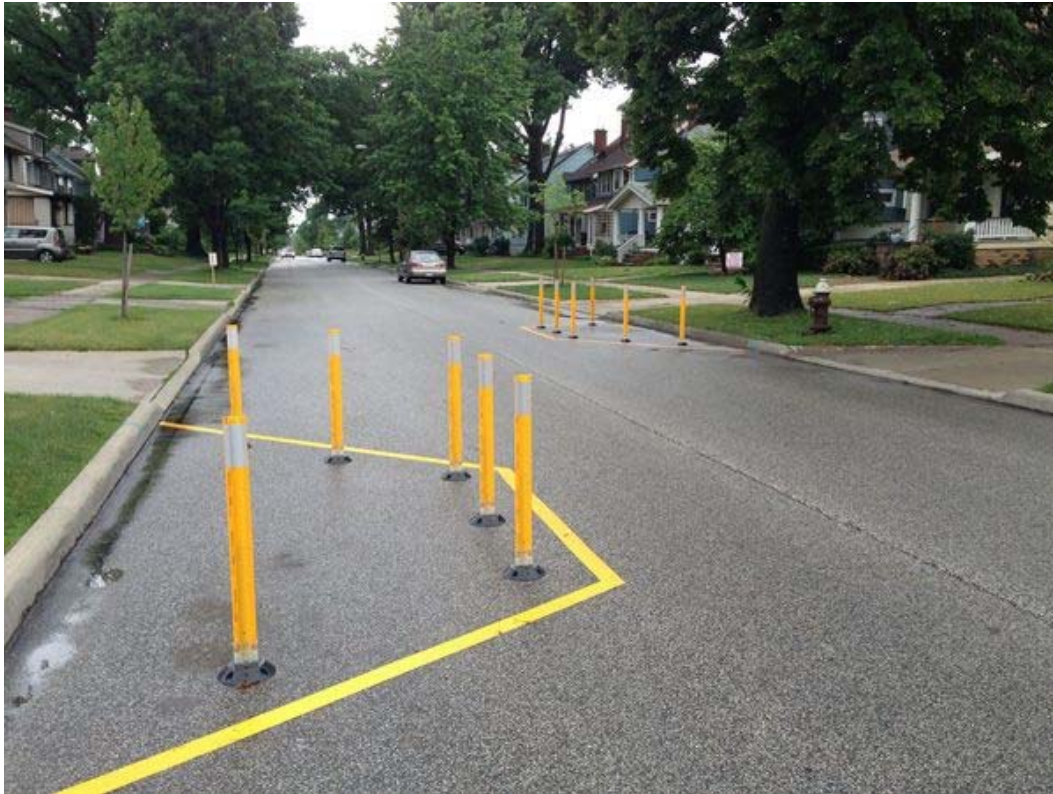
Sample picture of Pavement Marking Chicane

It is recommended the Town consider implementing traffic calming measures such as chicanes, rain gardens with curb extensions, speed humps and speed feedback radar signs on poles at appropriate locations to warn and slow motorists traveling on Metcalf Drive. See samples of traffic calming pictures in Appendix A.

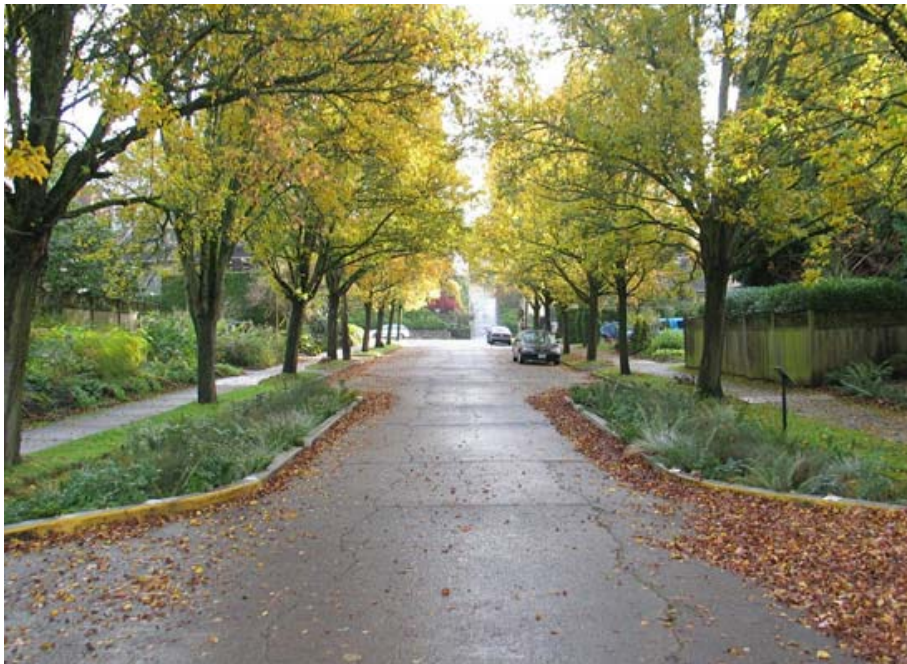
Sample picture of Rain Gardens with curb extensions
Photo Courtesy: <https://Brooklyncountrylane.wordpress.com>

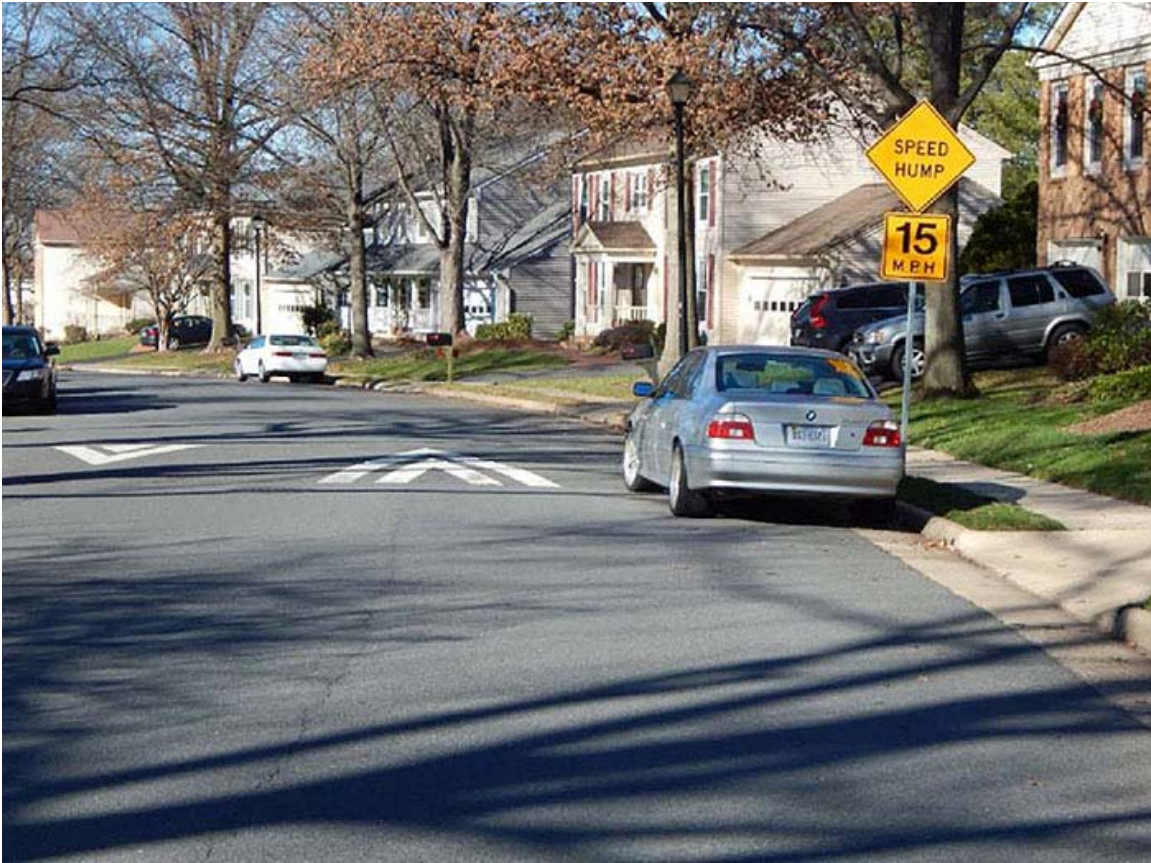
Sample picture of Speed Hump

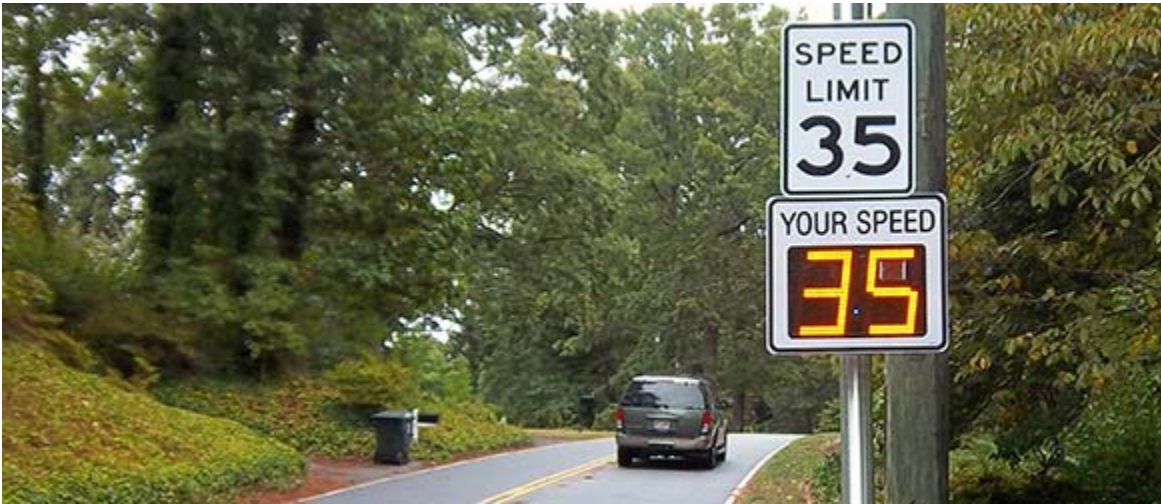
Sample picture of Speed Feedback Radar Sign
