MEMO

SUBJECT: North Williston Road – Mountain View Road Multi-Way Stop Warrant Analysis

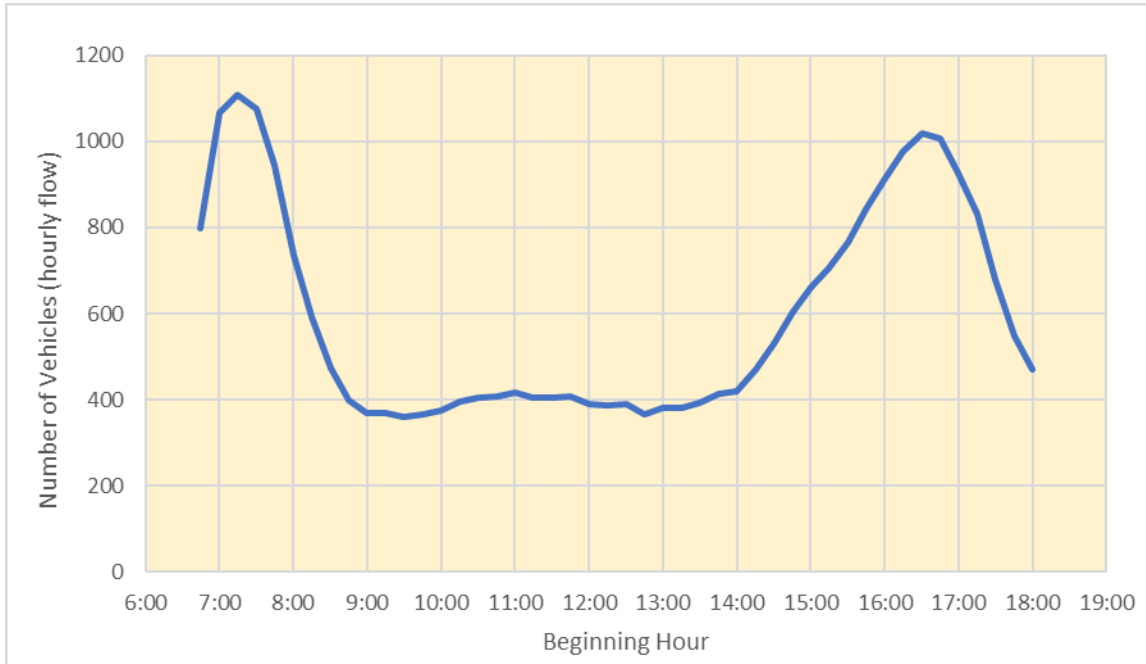
FIGURE 1: HOURLY FLOW IN INTERSECTION (12 HR) – UNADJUSTED 27 MARCH 2018

The heaviest hour during the observation occurred between 7:15 and 8:15 in the morning with 1,109 vehicles passing through the intersection. The PM peak hour occurred between 4:15 and 5:15 with 1,017 vehicles.

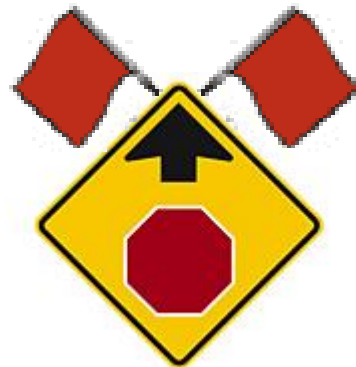
If the Town decides to implement multi-way stop control, the town is advised to implement short-term, high-visibility advance warning devices to alert drivers who may not expect the change in traffic control at this location. These short-term devices may include advance warning “STOP AHEAD” signs with supplementary reflective flagging, changeable message signs, or other devices as approved by the MUTCD.

FIGURE 2: MUTCD R3-1 WITH TEMPORARY FLAGGING.
