Mountain View Road Crosswalk Location Analysis

Introduction

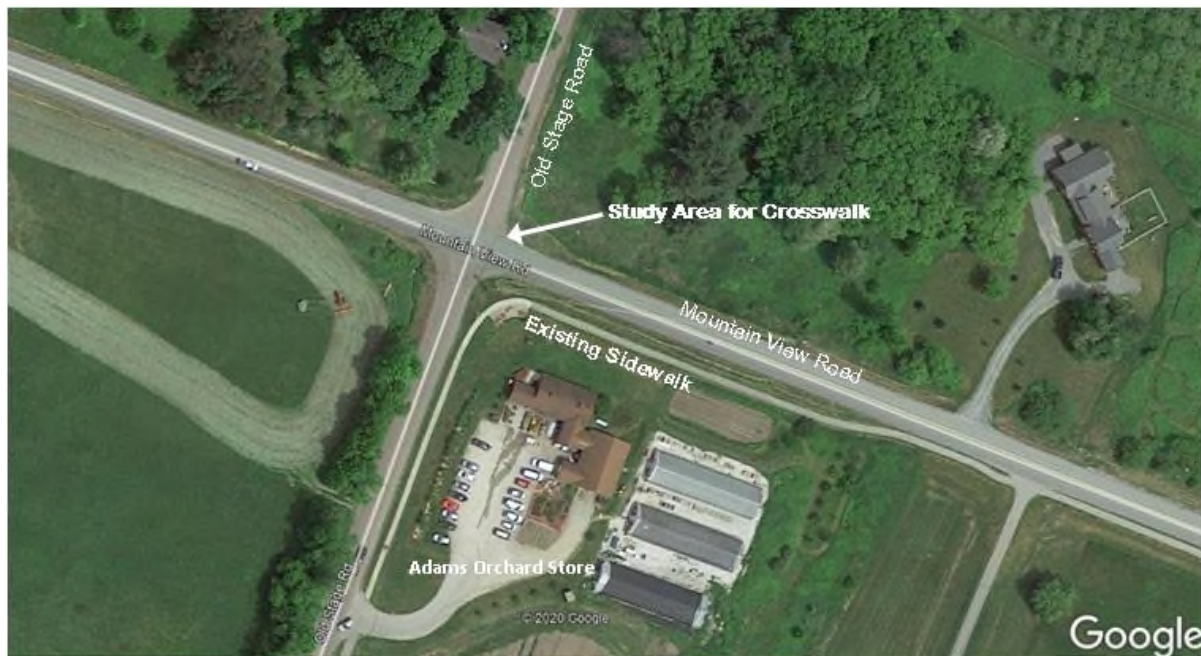
Figure 1: Study Area

Mountain View Road is classified by the state as a Class II Town Highway and functionally classified as a Major Collector, whereas Old Stage Road is classified by the state as a Class III Town Highway and functionally classified as a Local Road. The CCRPC staff conducted a field survey on October 14, 2020 between 4:00 pm and 5:30 pm to observe existing travel conditions, pedestrian activities and roadway characteristics at the study area shown in Figure 1.
