## Church Hill Road Speed Study

The Town of Charlotte requested the Chittenden County Regional Planning Commission (CCRPC) staff to conduct a speed study on Church Hill Road between US 7 and Hinesburg Road. As per the latest Motor Vehicle and Traffic Regulation ordinance adopted by the Town, no speed limit was adopted for Church Hill Road within the study area. In order for a Legislative Body to determine a safe and reasonable speed on town highways, a traffic engineering investigation (speed study) is required by the Vermont Statutes Annotated Title 23, § 1007. This document provides supporting findings that were used to develop recommendations for setting a speed limit on Church Hill Road.

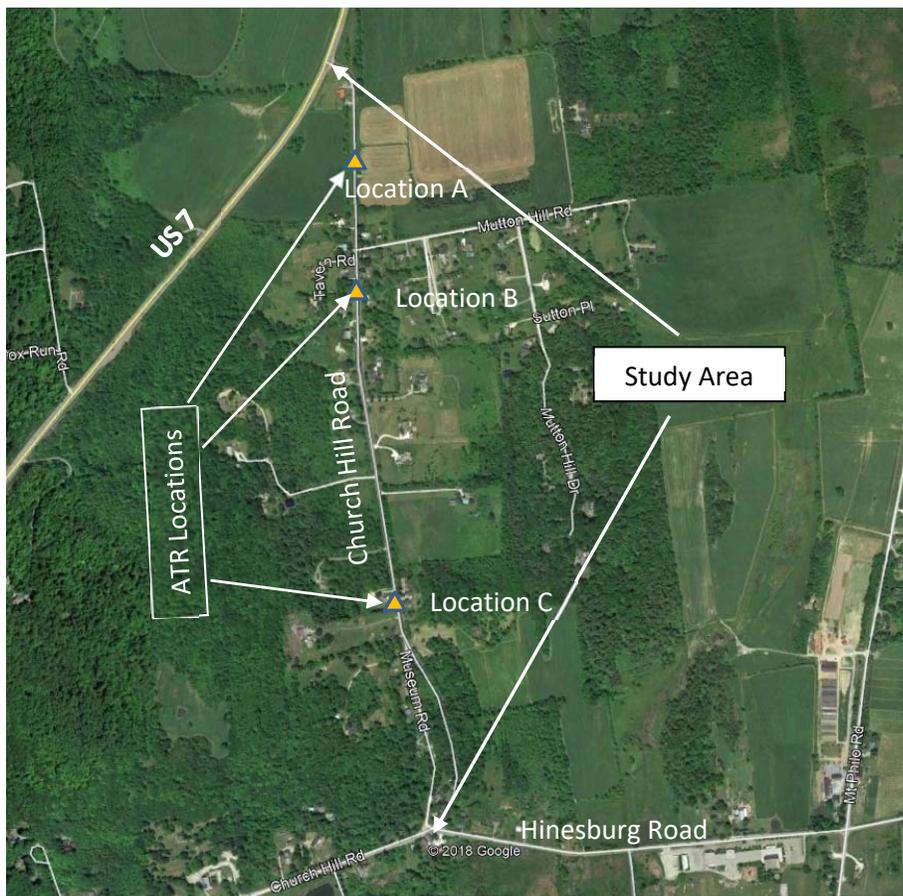
**Figure 1: Study Area and ATR Locations**

Church Hill Road is paved and classified by the state as a Class II Town Highway and functionally classified as a Rural Minor Collector. The CCRPC installed three Automatic Traffic Recorders (ATR) along Church Hill Road at locations shown in Figure 1 to collect traffic volume and speed data. Data were collected between May 07, 2019 to May 13, 2019. Figure 1 shows the study area and ATR locations.

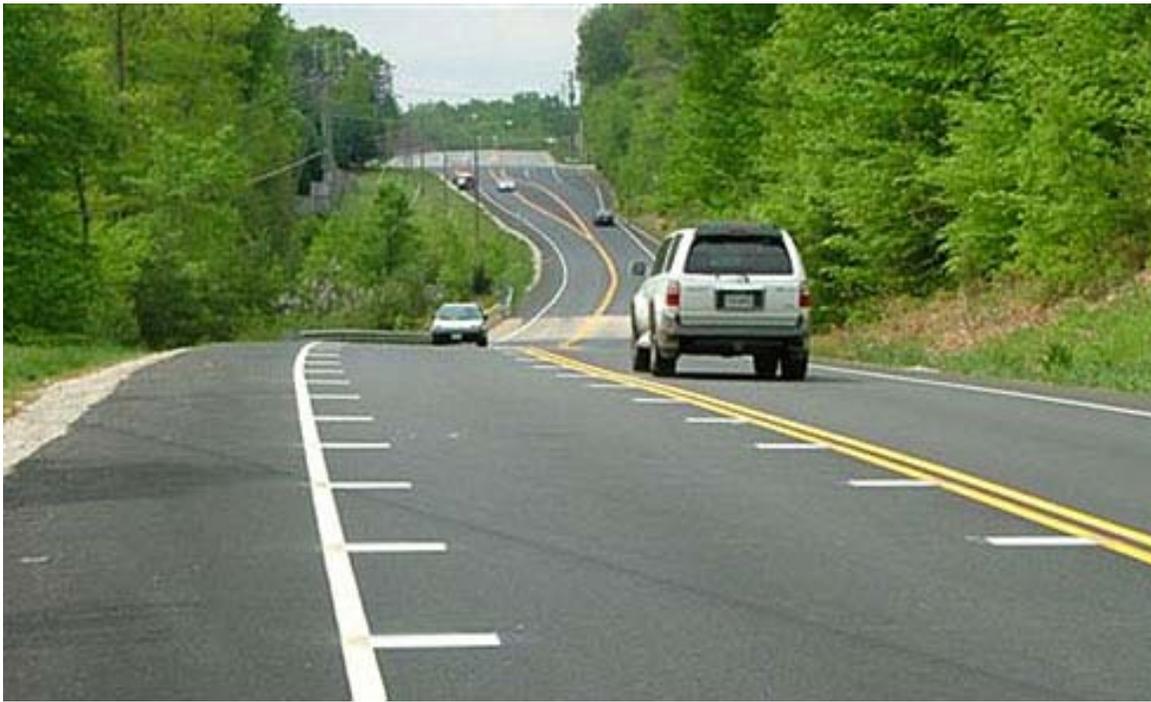
Sample of Optical Speed Bars

It is recommended the Town consider implementing traffic calming measures such as speed feedback radar signs on poles and optical speed bars at appropriate locations to warn and slow motorists traveling on Church Hill Road. Optical speed bars are a series of white rectangular pavement markings typically 1 foot wide placed just inside both edges of the lane and spaced progressively closer to create an illusion of traveling faster as well as the impression of narrower lane. See picture in Appendix B.
